# Inspection Report

**Property Address:**  
1234 Main St  
Anywhere CT 54321

1/1/2021

**SafeGuard Home Inspection**

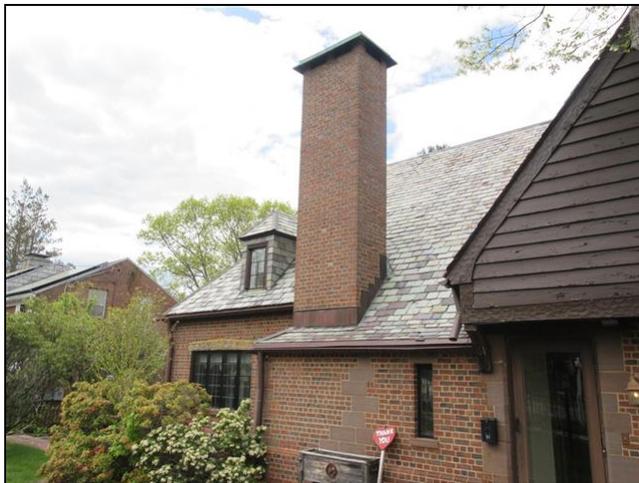
(1) **Observation:** The 1st chimney is located on the front of the home (when facing the front of the home). Condition of the chimney appears to be good. I did not note that any significant repointing is needed. The cap where visible, seems in good condition with no significant cracking noted. There appear to be two flue(s) and they appear(s) in good condition. The chimney is tight to the home, with no significant cracking noted. No significant brick damage was noted.

1.1 Item 1(Picture) 1st chimney

**Recommendation:** I do recommend you have the chimney cleaned and serviced if it has not been in the last year.

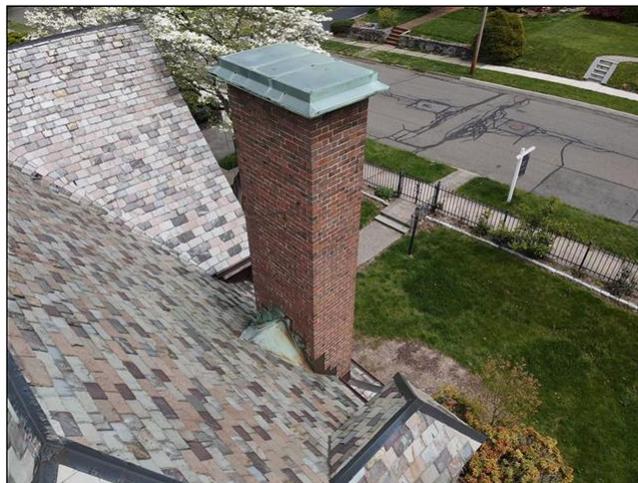
1.1 Item 3(Picture) 1st chimney

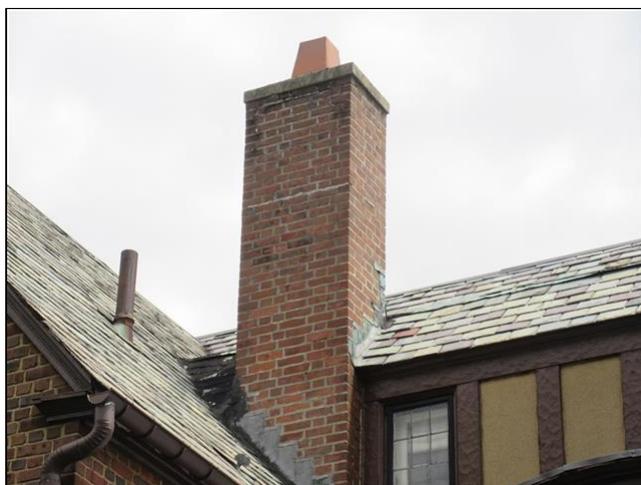
(2) **Observation:** The 2nd chimney is located in the center of the home (when facing the front of the home). Condition of the chimney appears to be good. I did not note that any significant repointing is needed. The cement cap appears to have some cracking. There appear to be one flue(s) and it appear(s) in good condition. The chimney is tight to the home, with no significant cracking noted. No significant brick damage was noted.

1.1 Item 4(Picture) 2nd chimney

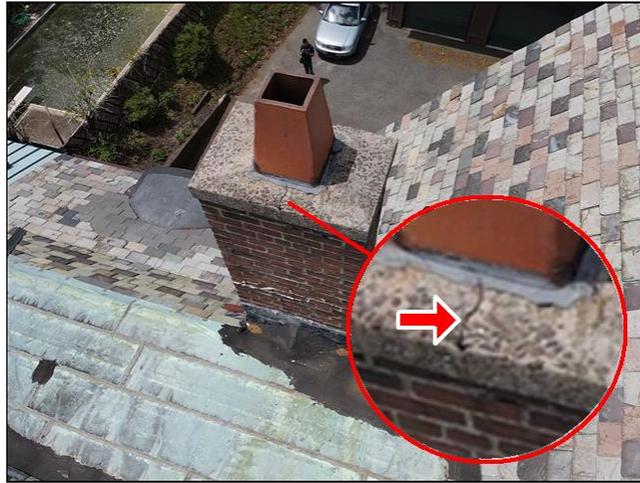
1.1 Item 6(Picture) Chimney cap crack

**Recommendation:** Recommend you have a licensed chimney company come out and evaluate the chimney cap cracking and at that time have them make recommendations.

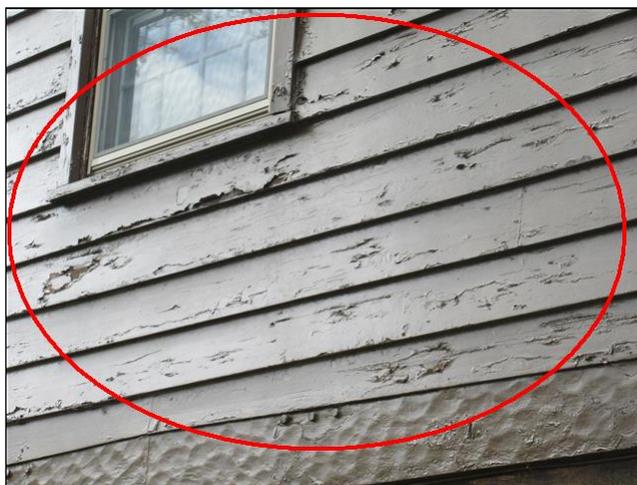
1.3 Item 1(Picture) Chipping paint

**Recommendation:** I do recommend you consult with a painting contractor regarding the chipping paint.

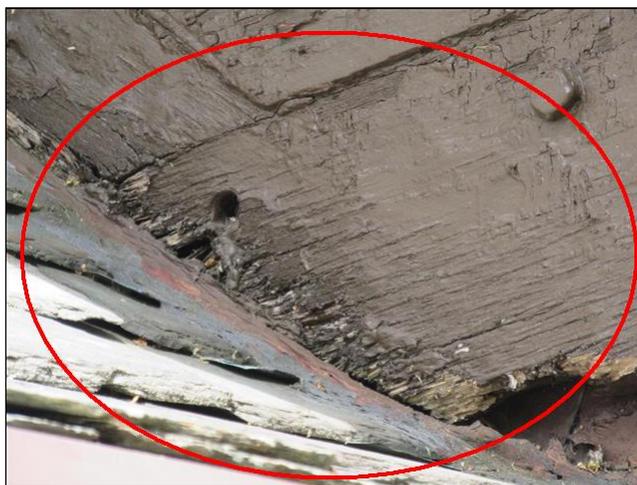
(2) **Observation:** I noted in several sections where wood siding is touching the roof shingles. This can cause rot where the siding meets the roof. I normally see a 1-2 inch spacing.

1.3 Item 2(Picture) Wood rot where siding in contact with shingles

**Recommendation:** Recommend you have a contractor come out and evaluate this and make recommendations.

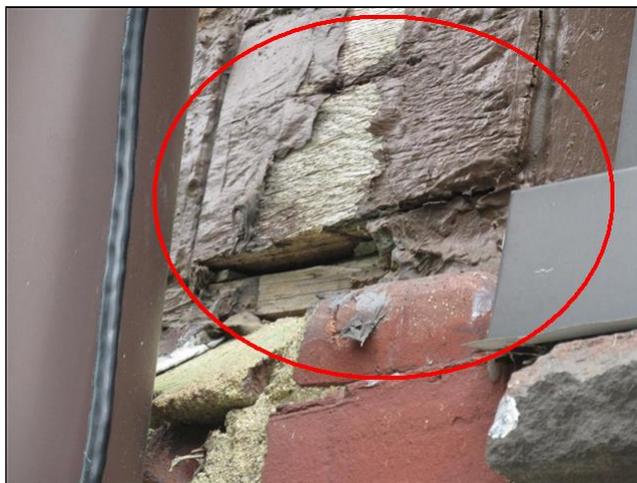
**Observation:** The wood trim on the house is deteriorating in several sections.

1.4 Item 1(Picture) Trim rot

**Recommendation:** Recommend that you have a contractor evaluate the entire trim on the home and at that time have them make repairs.

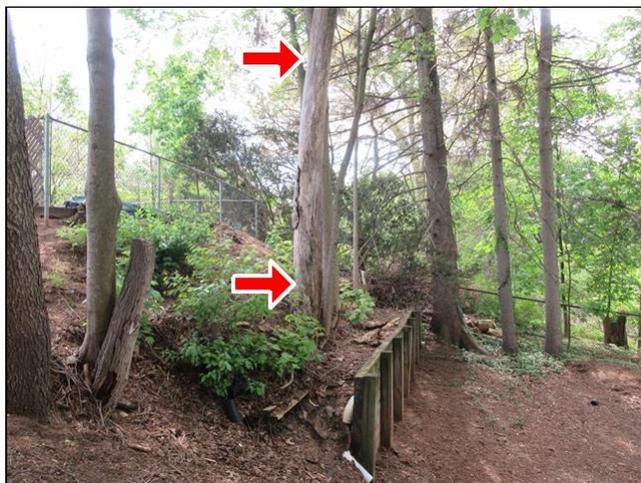
(3) **Observation:** I did note dead tree limbs that are overhanging the roof of the garage.

1.5 Item 1(Picture) Dead tree leading toward garage

**Recommendation:** Recommend you consult with a tree company concerning this issue.

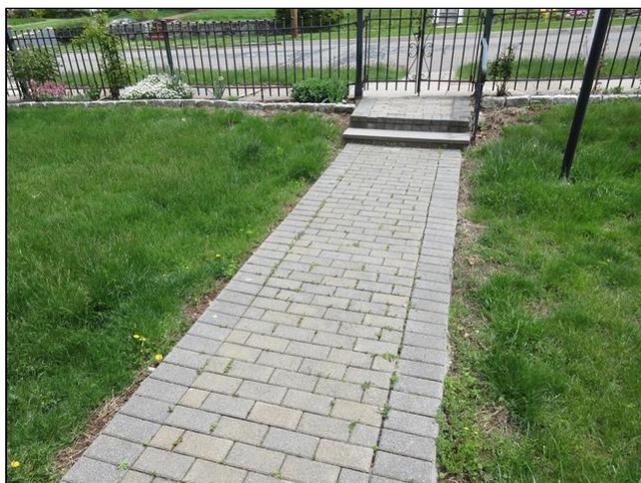
**Observation:** The front and side walkway appears to be pavers and are in good condition. I did not note any major cracking or depressions.

1.9 Item 1(Picture) Front walkway

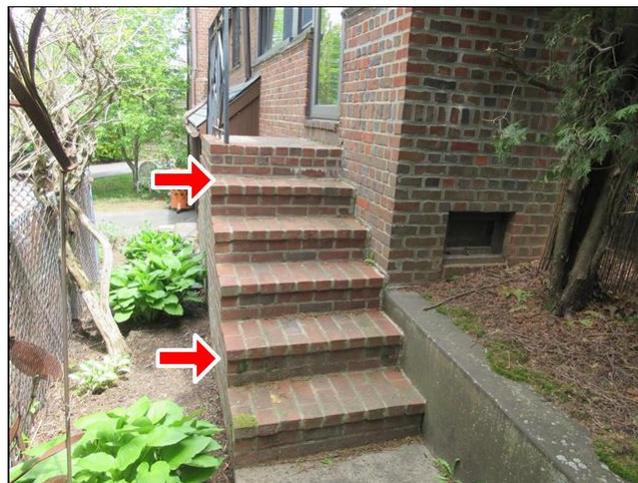
1.11 Item 1(Picture) Missing railings for stairs

(2) **Observation:** The stone steps to the right of the detached garage are deteriorating. I noted some loosed stone steps. I did note that there are no railings for the rear steps.

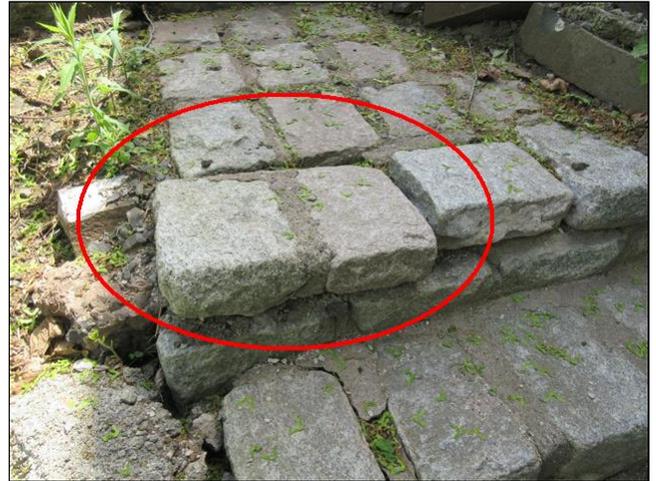
1.11 Item 3(Picture) Loose steps

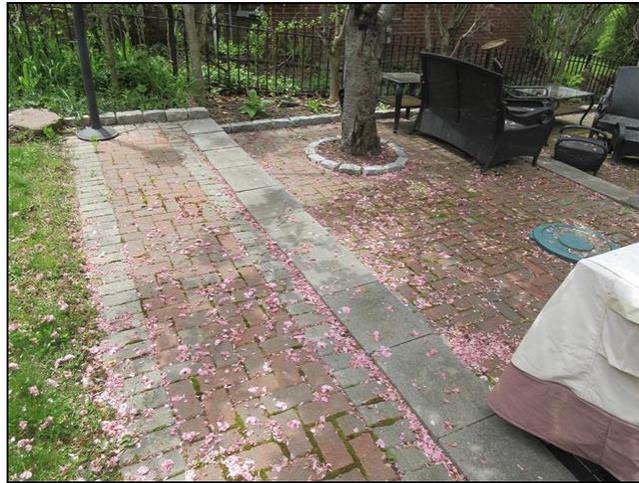
(1) **Observation:** There is a paver patio at the rear of the house and upon inspection seems to be in good condition. It was even and there was no standing water at the time of inspection.

1.12 Item 1(Picture) Rear patio

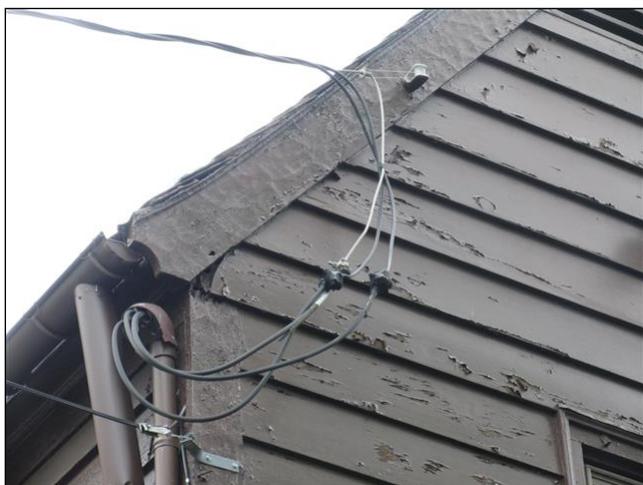
**Observation:** The electrical service entry at the time of the inspection shows no major issues, such as water intrusion, frayed wiring, etc. The box seemed secure and tight to the home. No significant issues were noted with the drip loop at the time of the inspection. The duct seal appears in good condition.

1.14 Item 1(Picture) Electrical service

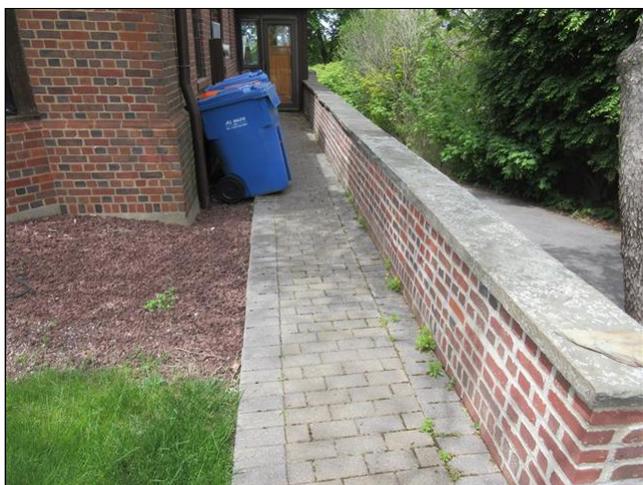
**Observation:** I noted retaining walls at the front and rear of the home. They appeared in good condition with no tilting, major cracking or bulging. I also did not note any significant vegetation that would affect the walls.

1.15 Item 1(Picture) Side retaining wall

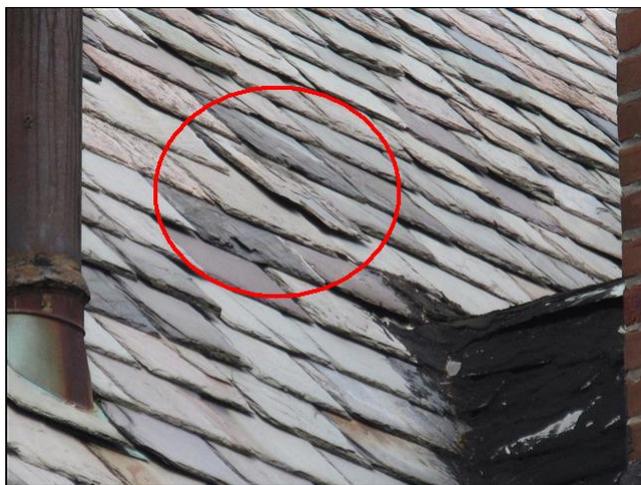
2.0 Item 1(Picture) Detached shingle

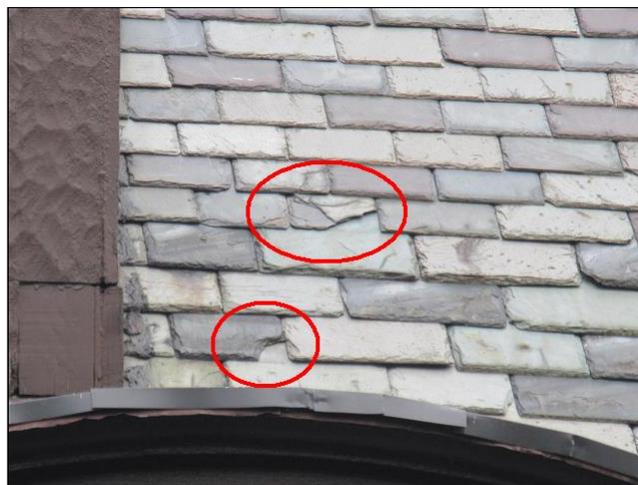
2.0 Item 2(Picture) Damaged shingles

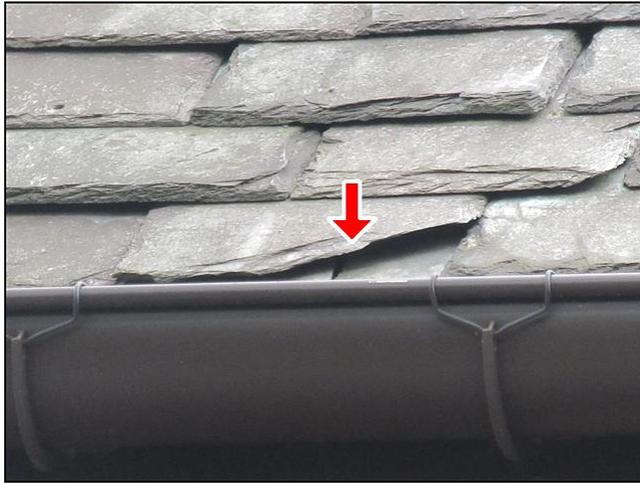
2.0 Item 3(Picture) Damaged/missing shingles

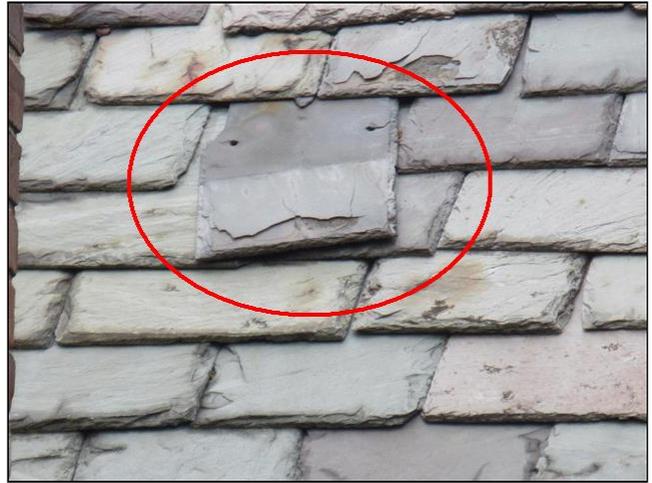
2.0 Item 4(Picture) Detached shingle

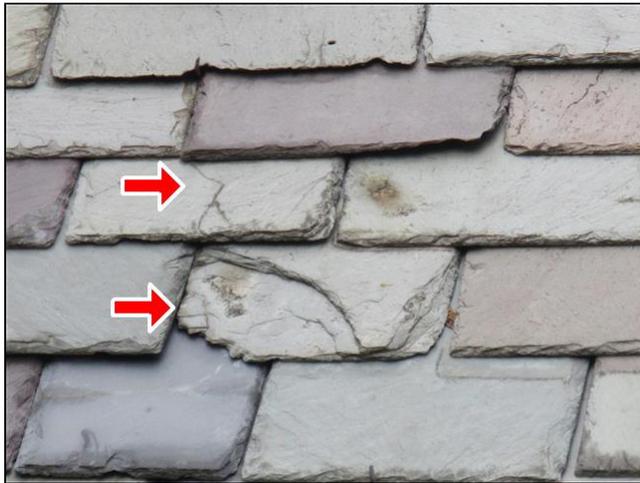
2.0 Item 5(Picture) Damaged/missing shingles

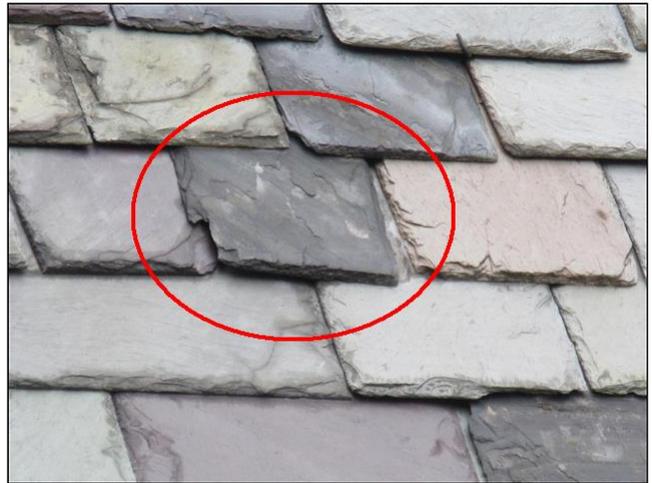
2.0 Item 6(Picture) Detached shingle

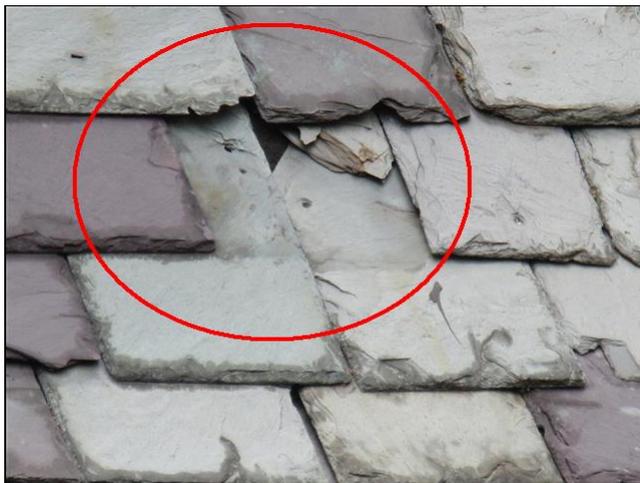
2.0 Item 7(Picture) Damaged/missing shingles

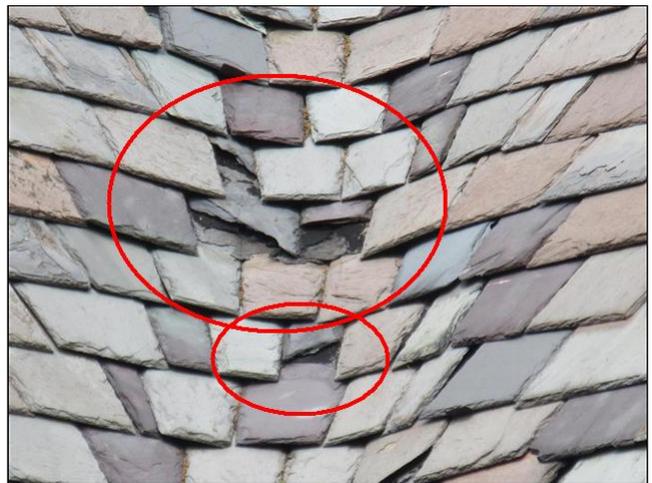
2.0 Item 8(Picture) Damaged/missing shingles

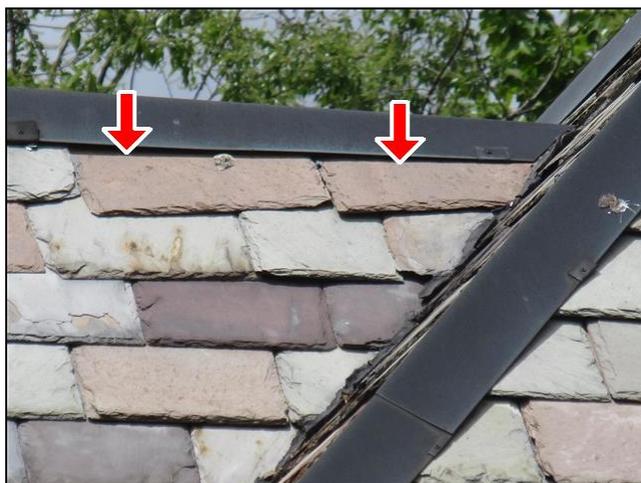
2.0 Item 9(Picture) Detached shingles

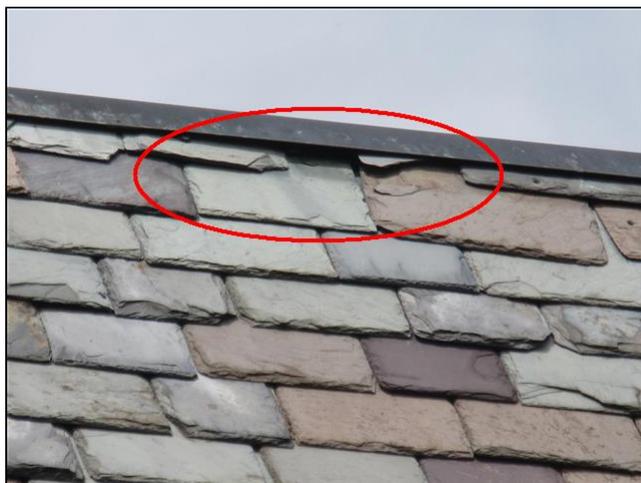
2.0 Item 11(Picture) Damaged/missing shingles

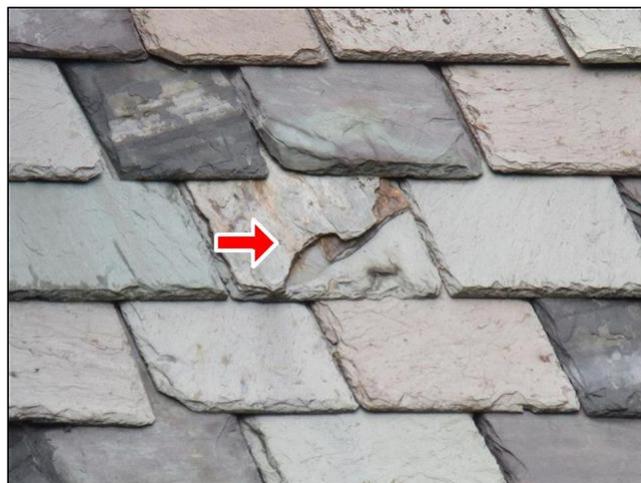
2.0 Item 12(Picture) Damaged/missing shingles

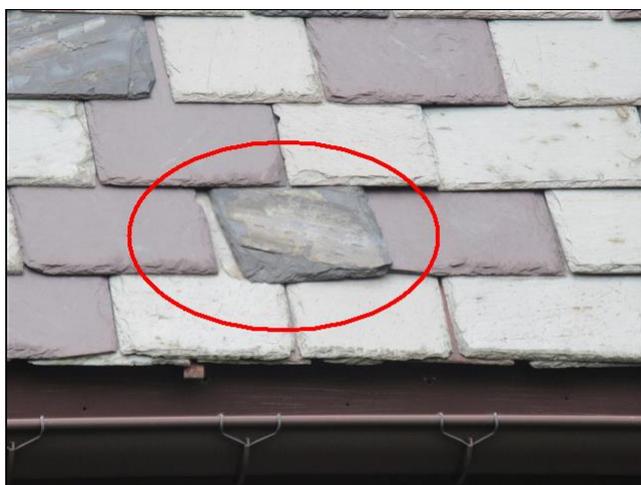
2.0 Item 13(Picture) Detached shingle

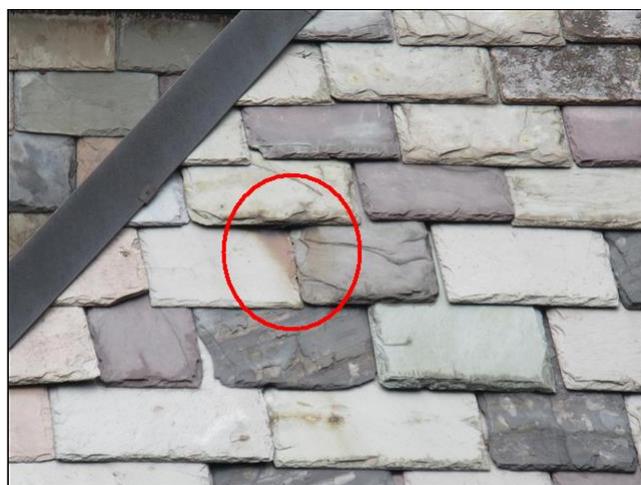
2.0 Item 14(Picture) Staining from nails/fasteners

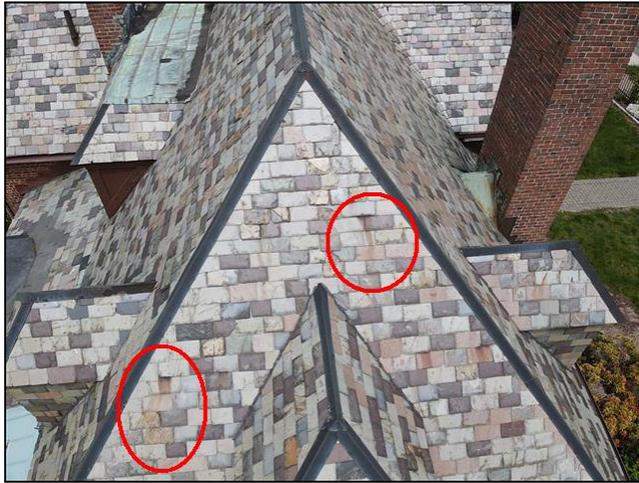
2.0 Item 15(Picture) Staining from nails/ fasteners

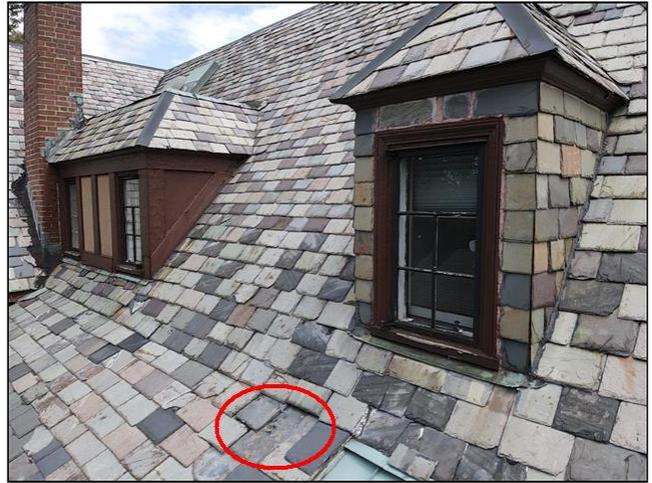
2.0 Item 16(Picture) Damaged/missing shingles

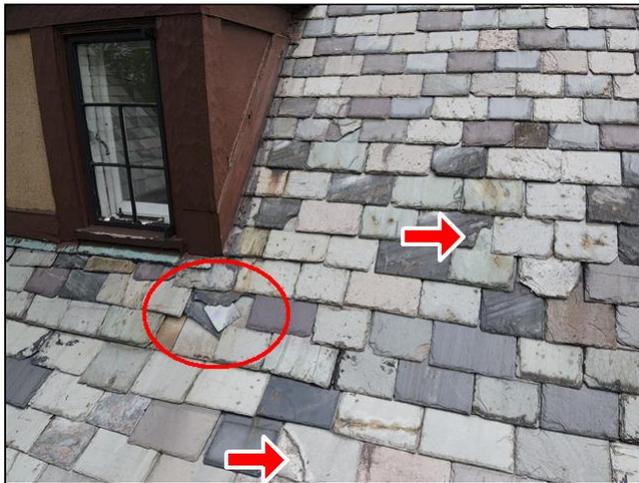
2.0 Item 17(Picture) Damaged/missing shingles

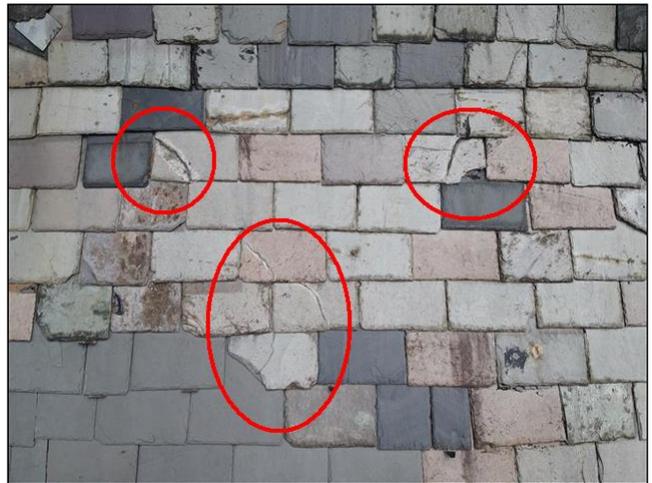
2.0 Item 18(Picture) Damaged/missing shingles

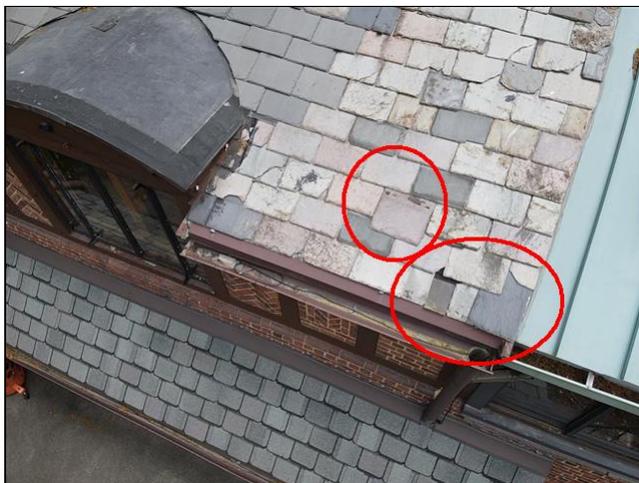
2.0 Item 19(Picture) Damaged/missing shingles

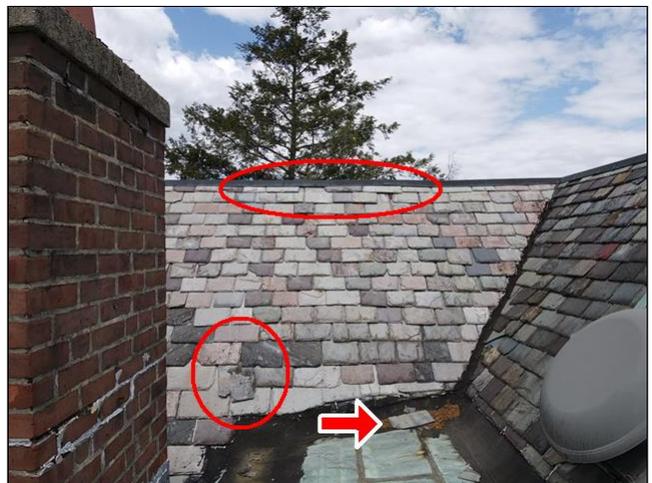
2.0 Item 20(Picture) Damaged/missing shingles

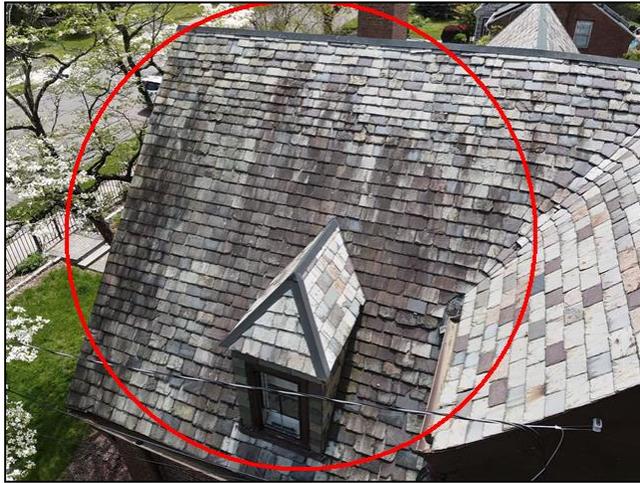
2.0 Item 21(Picture) Staining on shingles

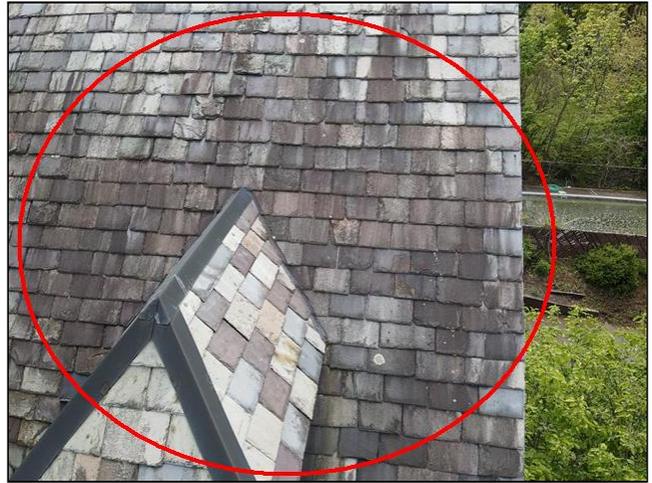
2.0 Item 22(Picture) Staining on shingles

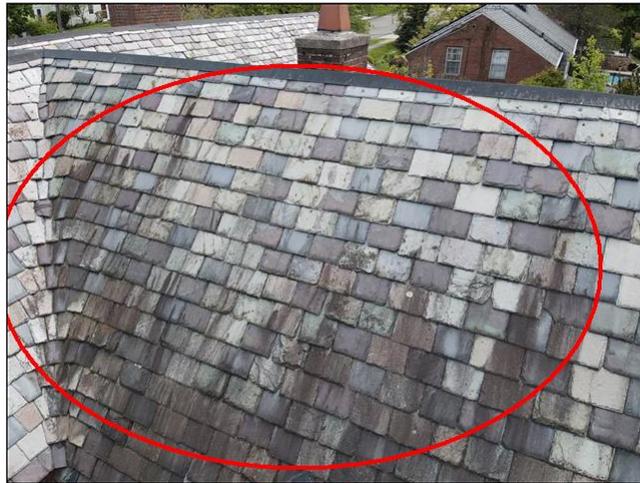
2.0 Item 23(Picture) Staining on shingles

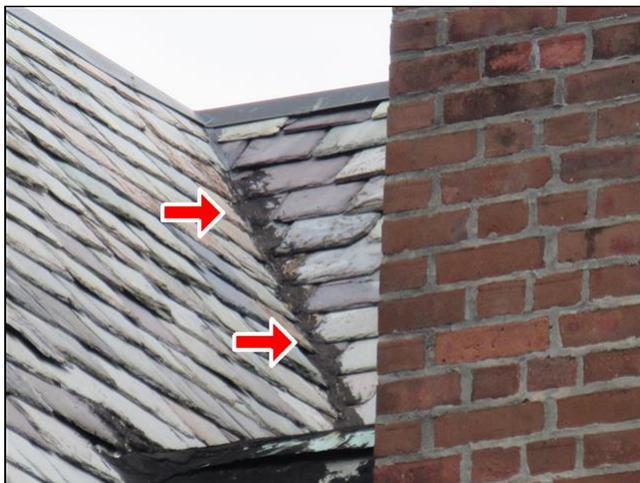
(2) **Observation:** I noted the valleys on the roof appear to have been tarred. Tarred valleys are a sign of leaking, caused by incorrect installation, or failing of the roof.

2.0 Item 24(Picture) Tarred valley

**Recommendation:** I recommend you have a roofing contractor come out and evaluate the roof and its valleys and at that time have them make recommendations.

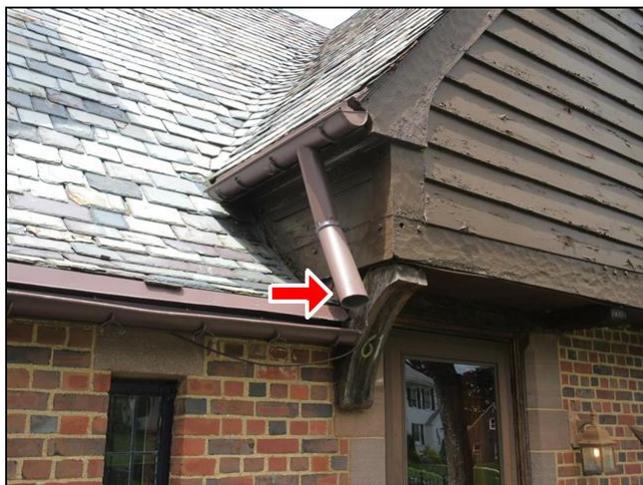
I noted missing downspouts on the home.

2.3 Item 1(Picture) Missing downspout

**Recommendation:** I do recommend you have the downspouts and gutter system as a whole evaluated by a licensed contractor.

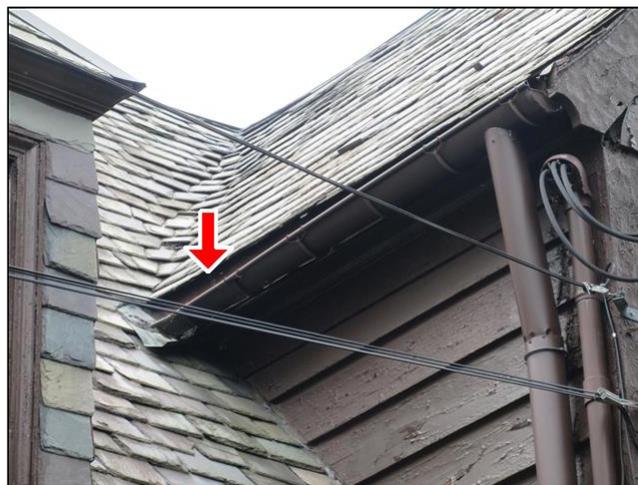
2.3 Item 2(Picture) Gutter not pitched correctly

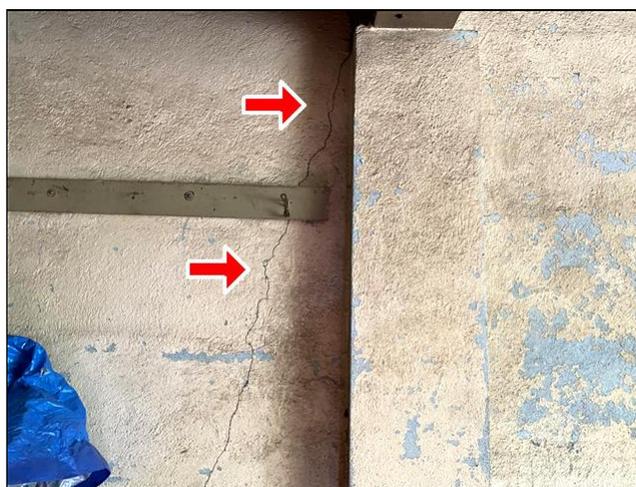
3.0 Item 1(Picture) Foundation crack

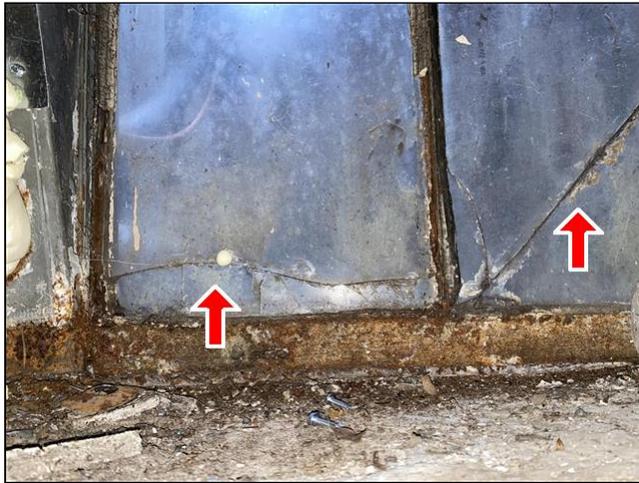
**Observation:** The basement windows have broken glass and unsealed areas where light is shining through.

4.3 Item 1(Picture) Broken glass

**Recommendation:** Recommend having them fixed where necessary.

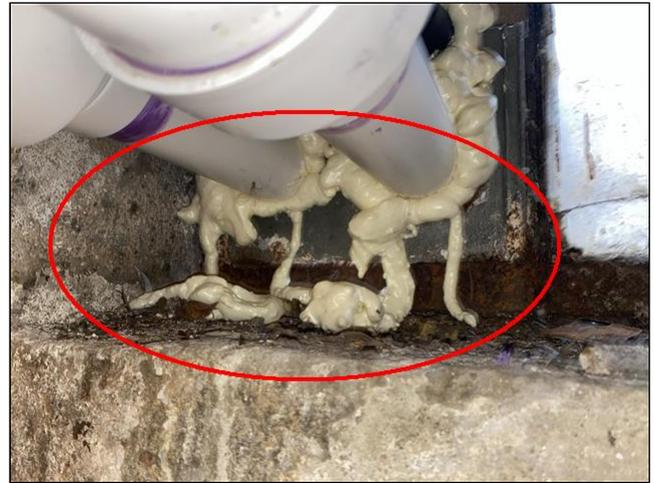
4.3 Item 2(Picture) Vents not sealed

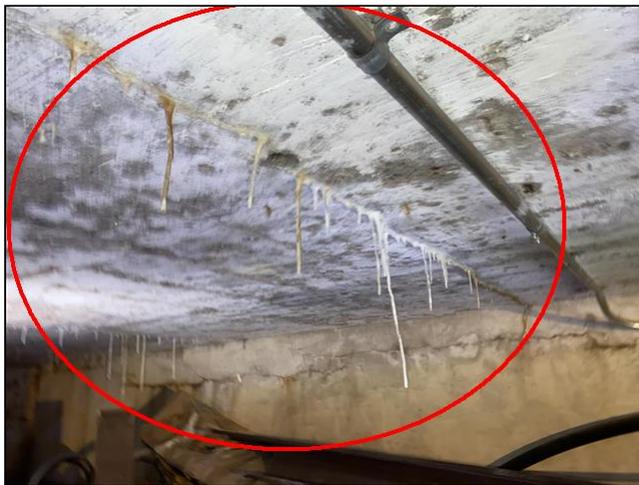
**Observation:** I found some white efflorescence (powder substance) on the basement cement walls which may indicate that moisture has been or is in contact with the masonry. This does not necessarily indicate that intrusion will occur. I recommend checking the gutters and the downspout drain lines for proper operation. Also, a water proofing paint could be applied to the interior side of the block if necessary. Efflorescence is found on many homes without water intrusion occurring inside the home. But, it should alert you to the possibility that future steps may be needed.

4.7 Item 1(Picture) Active water intrusion

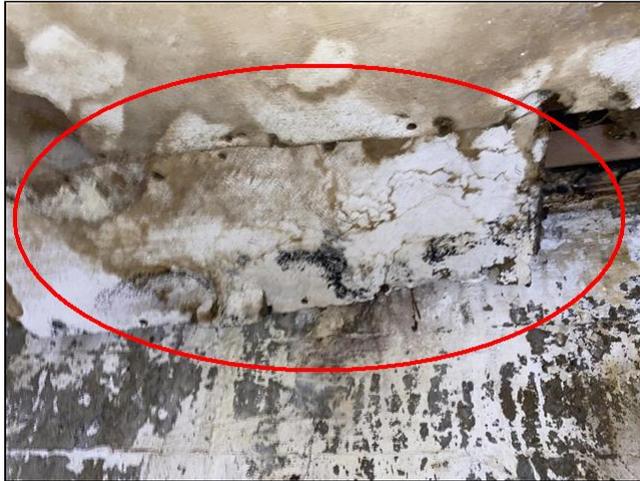
4.7 Item 5(Picture) Mold-like substance in basement

**Recommendation:** I do recommend that you have a mold remediation company come in and evaluate this material and at that time make recommendations.

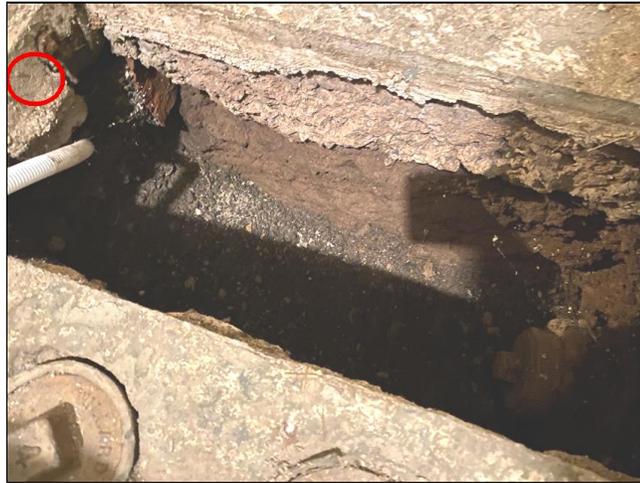
**Observation:** There is no formal drain in the basement. I did note a hole cut in the floor so that water will drain into the ground under the foundation. This is not uncommon for a home of this age.

4.9 Item 1(Picture) Hole in floor for drainage

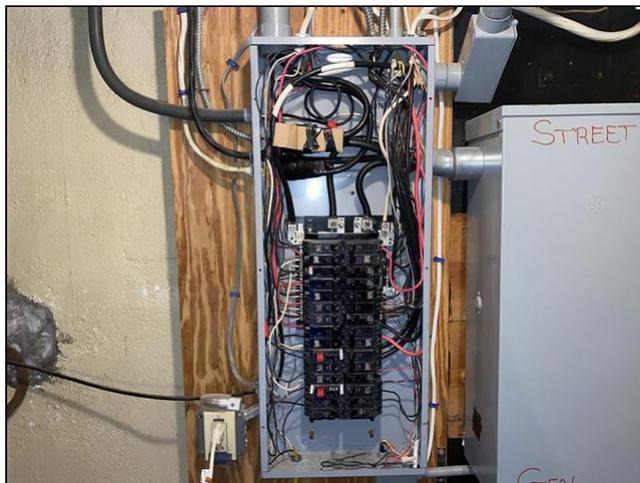
6.0 Item 1(Picture) Main panel

**Recommendation:** I did note the presence of double tapped circuits and combustible material inside the box. This is a safety concern and I strongly recommend that you have a licensed electrician come out evaluate the electrical box and make corrections at that time.

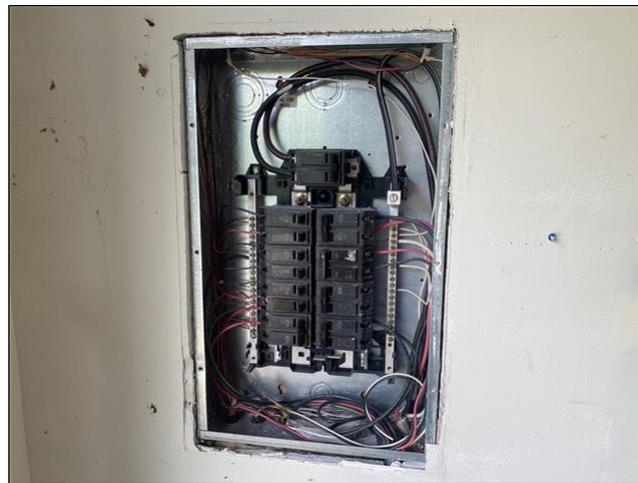
6.0 Item 7(Picture) Sub panel 2

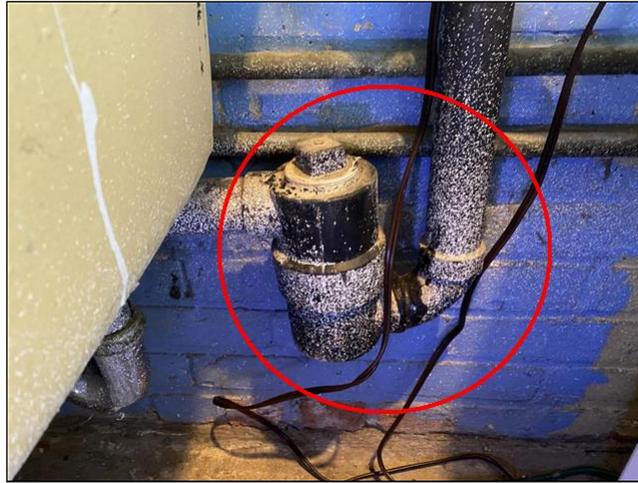
7.1 Item 1(Picture) Drum trap for washer

**Recommendation:** I recommend you have a licensed plumber evaluate the drum trap drain and make recommendations.

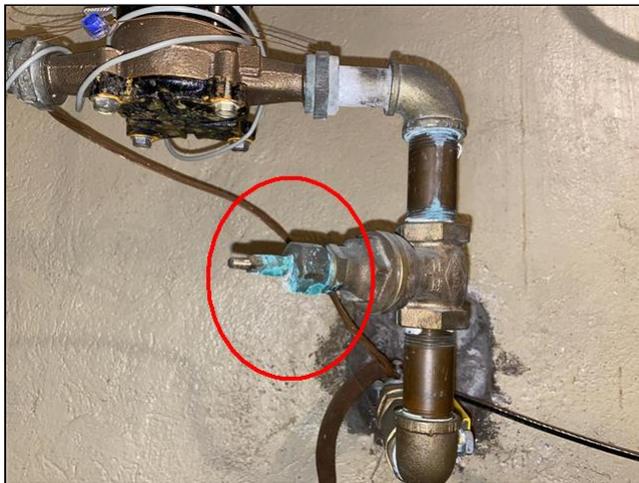
7.2 Item 1(Picture) Leaking shutoff

**Recommendation:** Recommend you have a plumber come out evaluate all the water pipes in the home and at that time have them make repairs as needed.

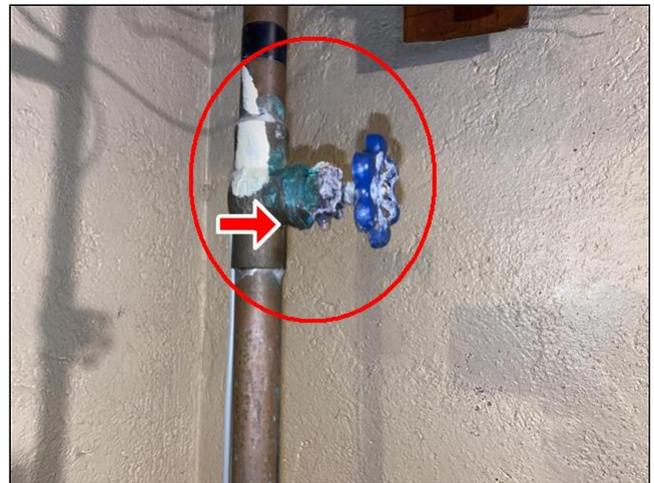
7.2 Item 2(Picture) Leaking shutoff

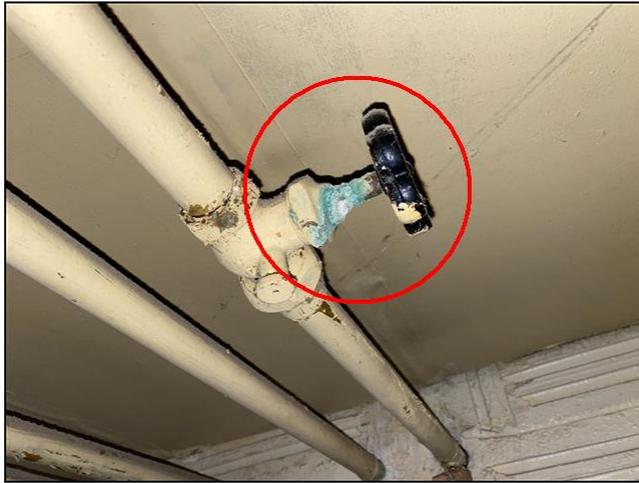
7.2 Item 3(Picture) Corrosion on shutoff

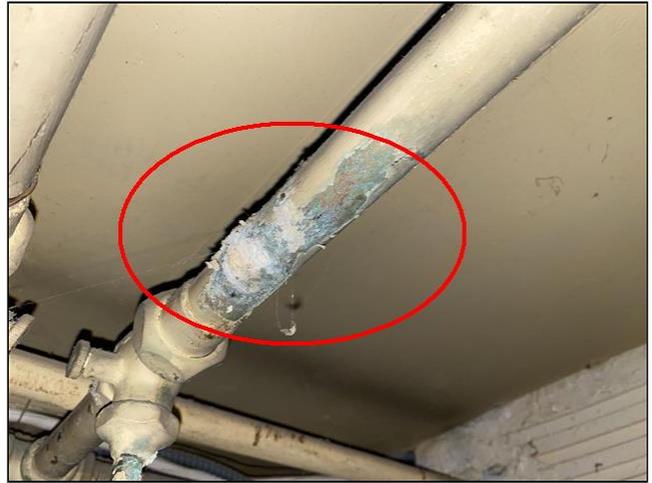
7.2 Item 4(Picture) Corrosion on water pipe

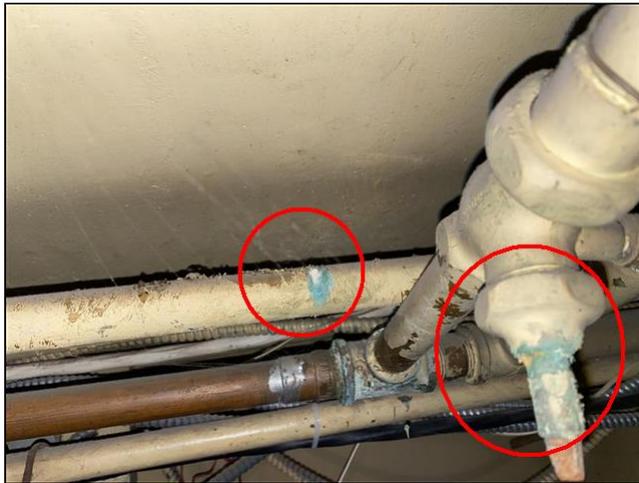
7.2 Item 5(Picture) Corrosion on water pipe and shutoff

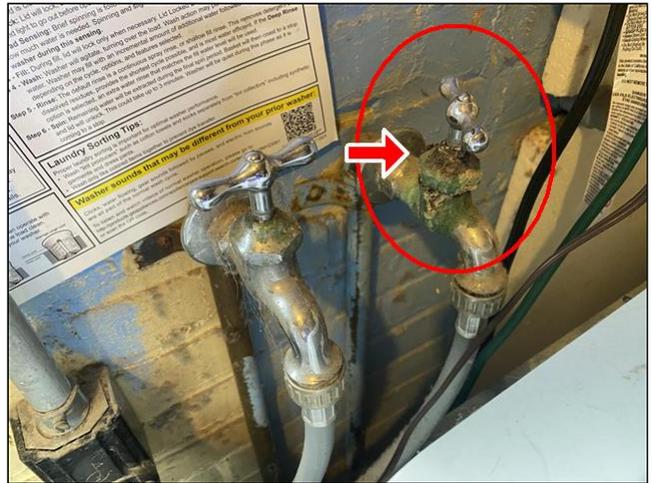
7.2 Item 6(Picture) Rusted & corroded shutoff

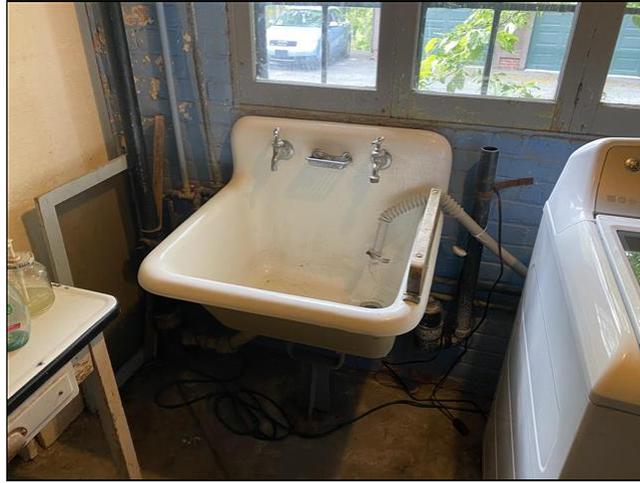
**Observation:** There is a laundry tub in the basement. I ran water and did not note any leaking at the time of my inspection. Hot and cold water was noted from the faucet.

7.5 Item 1(Picture) Laundry tub

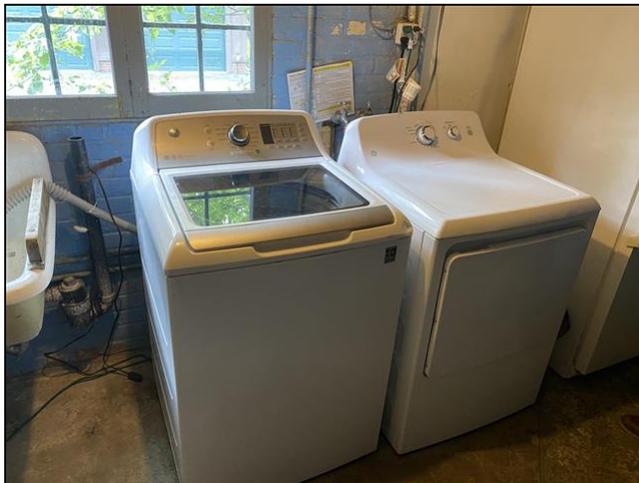
7.6 Item 1(Picture) Washer & dryer

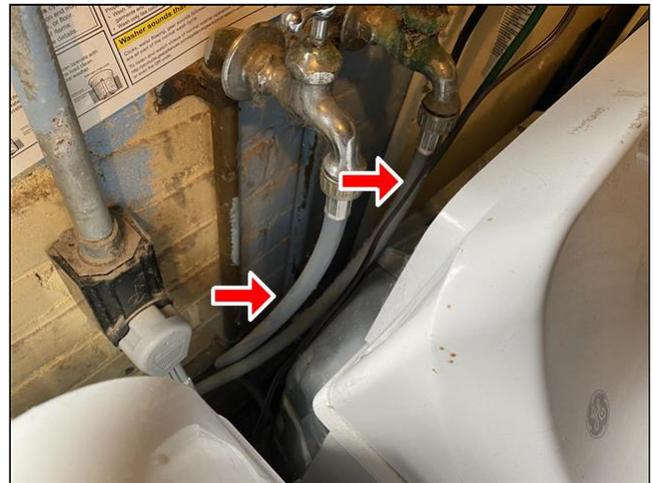
7.6 Item 2(Picture) Rubber hoses (recommend upgrade)

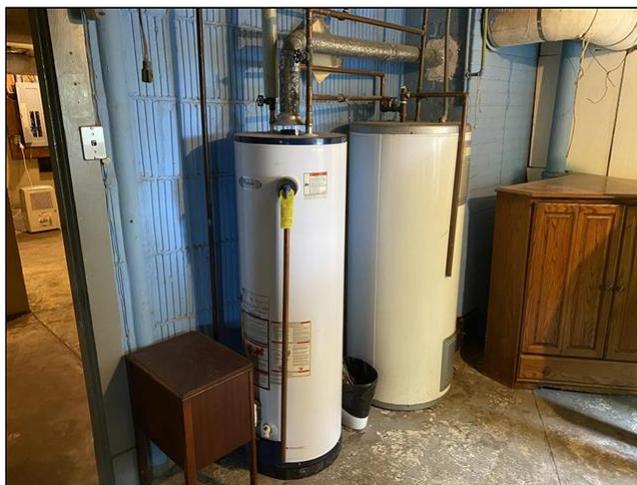
7.7 Item 1(Picture) Water heaters

**Special Note:** Recommend draining and flushing unit at least once a year to reduce deposits/noise and extend life. Note: The T&P valve is a safety device that releases water from the heater (ideally to the outside of the dwelling) if the temperature of the water, or the pressure in the tank, reaches certain preset levels. This is so that water that may have exceeded the boiling point due to a runaway burner or electric element control that fails to function properly does not result in a steam explosion should the tank burst.

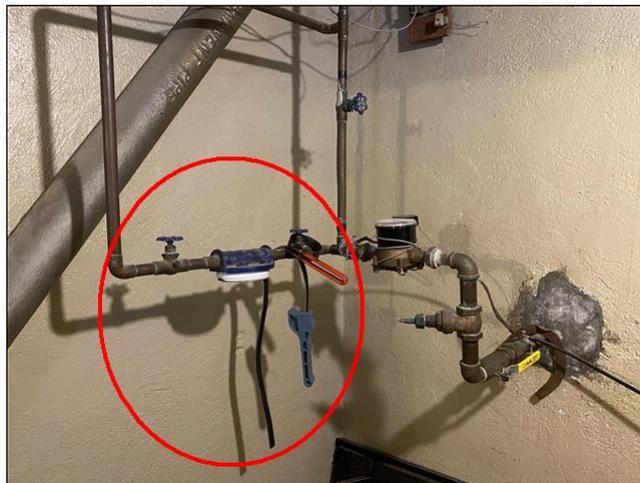
7.9 Item 1(Picture) Sediment filter

**Recommendation:** You may consider having a plumber evaluate the unit for routine maintenance.

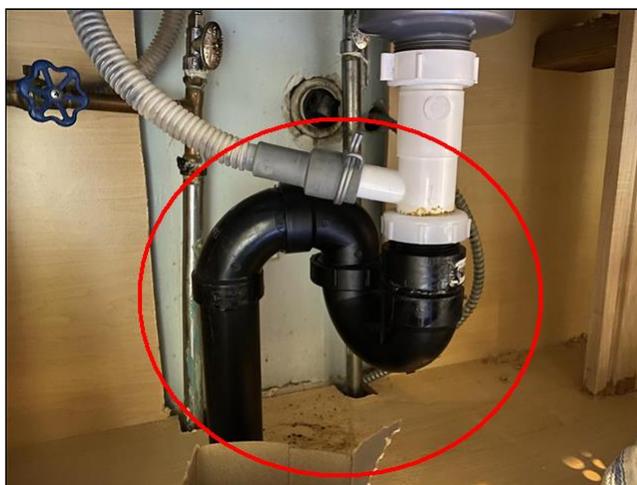
8.0 Item 1(Picture) "S" trap

**Recommendation:** Recommend you have a licensed plumber evaluate the trap and at that time have them make recommendations.

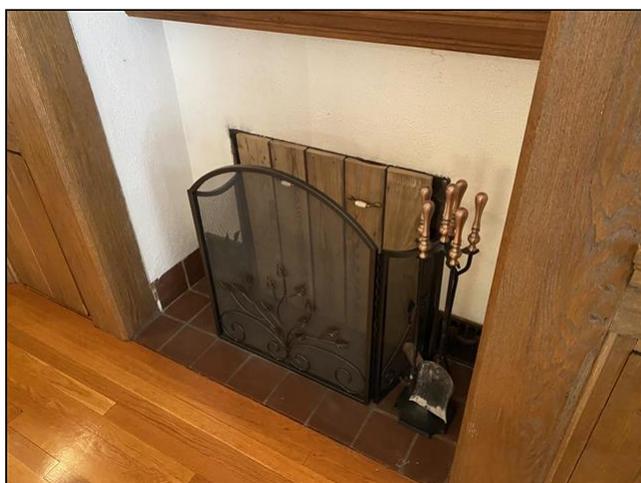
9.1 Item 1(Picture) Fireplace

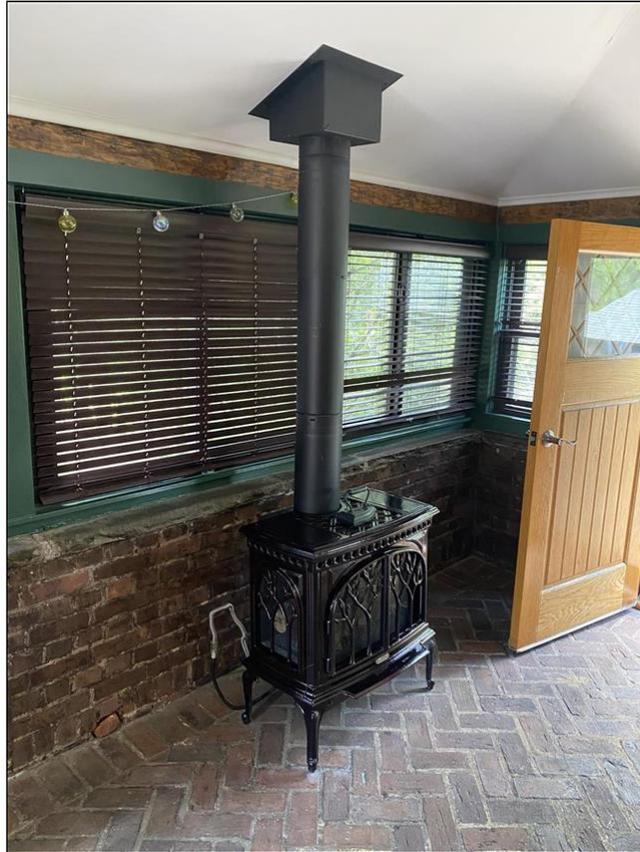
9.1 Item 4(Picture) Gas stove

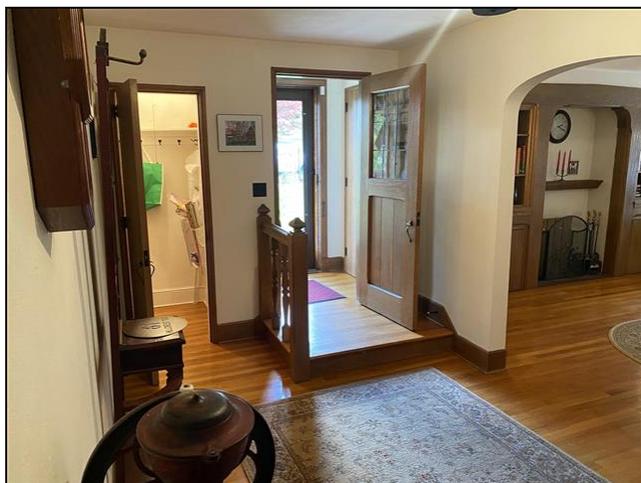
**Observation:** The entryway in the home appears in good condition. The floor appears solid under foot and level, with no significant issues noted. The walls appear to be in good condition, with no significant issues noted. The ceilings look in good condition with no cracking or staining noted at the time of the inspection.

9.2 Item 1(Picture) Front entryway

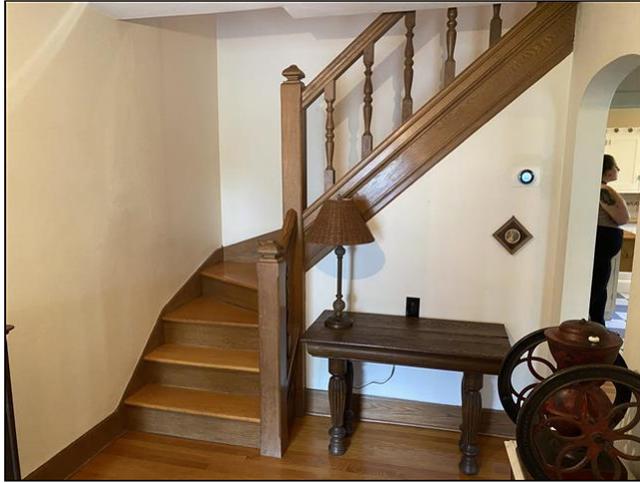
9.3 Item 1(Picture) Stairway

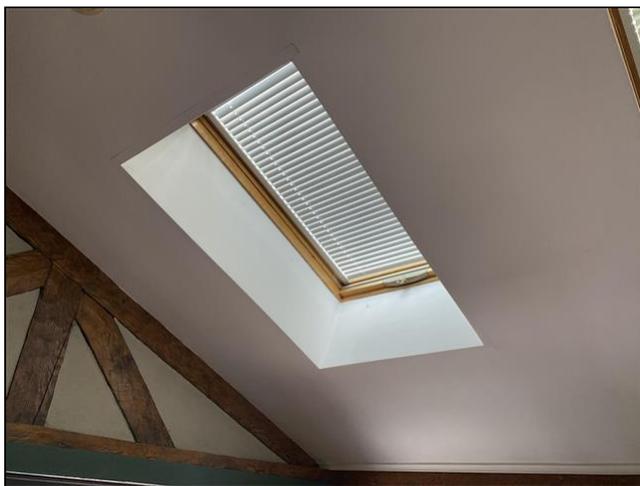
9.5 Item 1(Picture) Skylights
