# Inspection Report

**Property Address:**  
1234 Main St  
Anywhere CT 54321

1/1/2021

**SafeGuard Home Inspection**

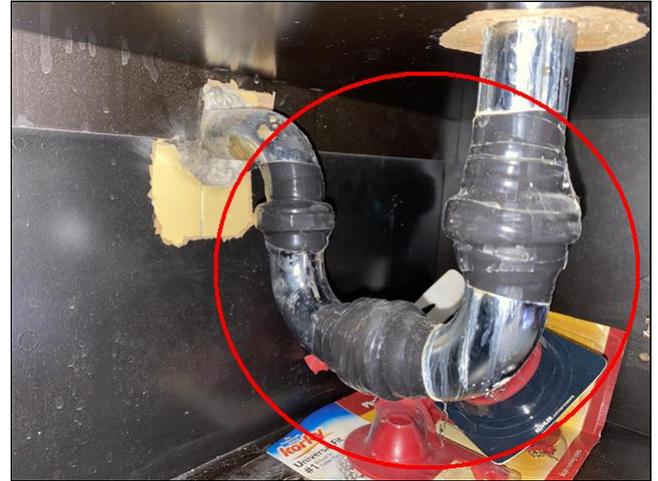
10.0 Item 2(Picture) Tape wrapped plumbing (evidence of leaking)

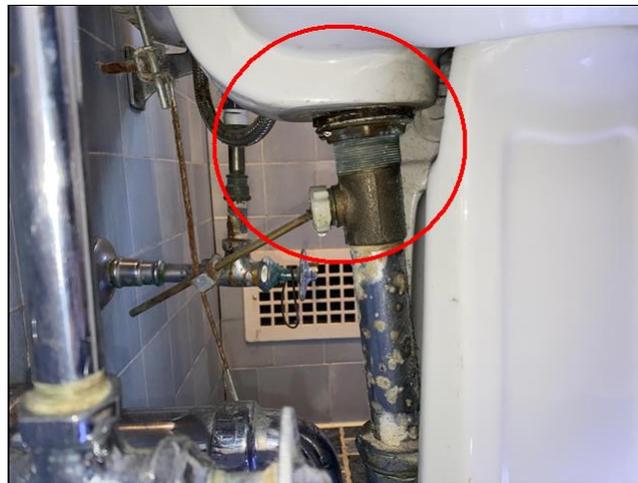
10.0 Item 3(Picture) Active leaking under sink

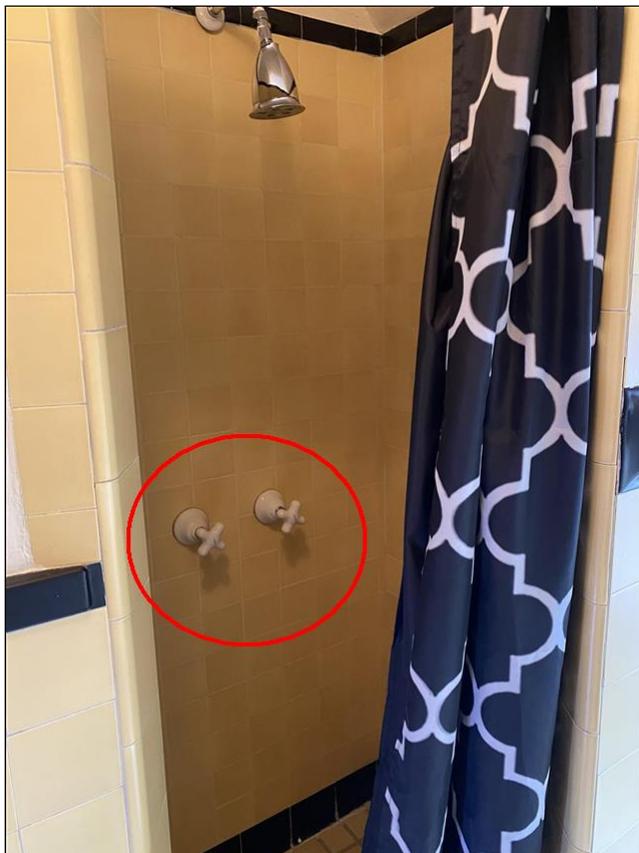
10.1 Item 1(Picture) No anti scald fixtures
