# Inspection Report

**Property Address:**  
1234 Main St  
Anywhere CT 54321

1/1/2021

**SafeGuard Home Inspection**

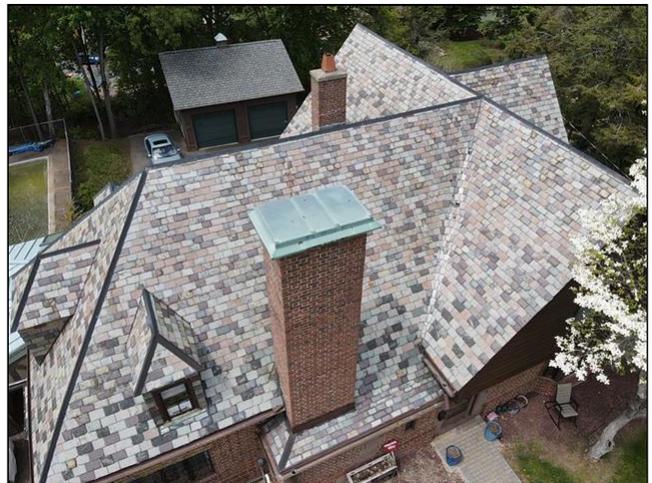
1.1 Item 2(Picture) 1st chimney

(1) **Observation:** The 1st chimney is located on the front of the home (when facing the front of the home). Condition of the chimney appears to be good. I did not note that any significant repointing is needed. The cap where visible, seems in good condition with no significant cracking noted. There appear to be two flue(s) and they appear(s) in good condition. The chimney is tight to the home, with no significant cracking noted. No significant brick damage was noted.

**Recommendation:** I do recommend you have the chimney cleaned and serviced if it has not been in the last year.

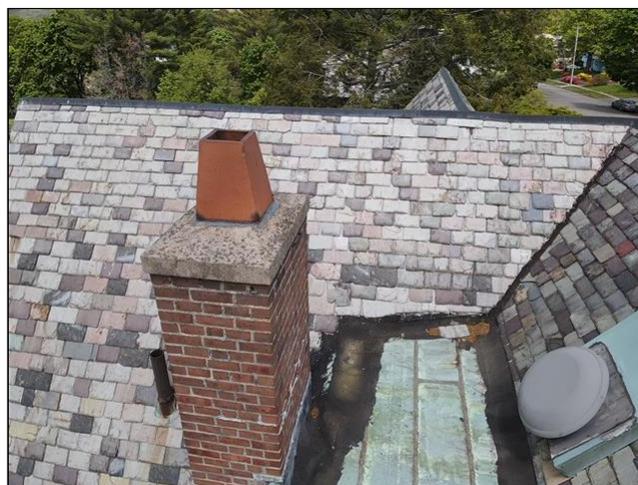
1.1 Item 5(Picture) 2nd chimney

(2) **Observation:** The 2nd chimney is located in the center of the home (when facing the front of the home). Condition of the chimney appears to be good. I did not note that any significant repointing is needed. The cement cap appears to have some cracking. There appear to be one flue(s) and it appear(s) in good condition. The chimney is tight to the home, with no significant cracking noted. No significant brick damage was noted.

**Recommendation:** Recommend you have a licensed chimney company come out and evaluate the chimney cap cracking and at that time have them make recommendations.

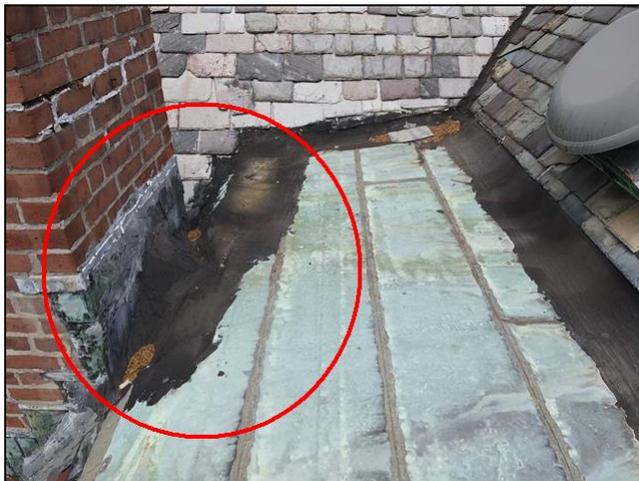
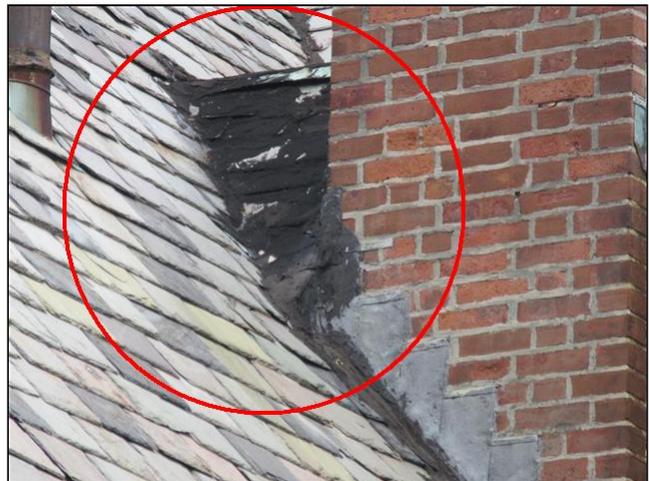
**Note:** Tarred flashing may be an indication that the original flashing has failed.

1.2 Item 1(Picture) Tarred chimney flashing

1.2 Item 2(Picture) Tarred chimney flashing

**Recommendation:** Recommend having a licensed chimney contractor evaluate the flashing and make recommendations.

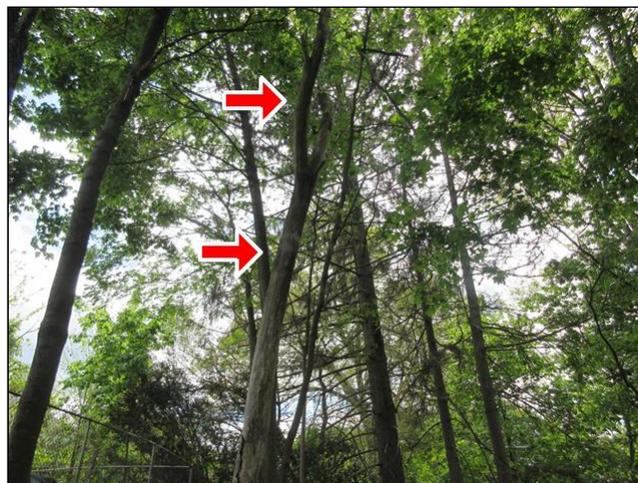
1.5 Item 2(Picture) Dead tree leading toward garage

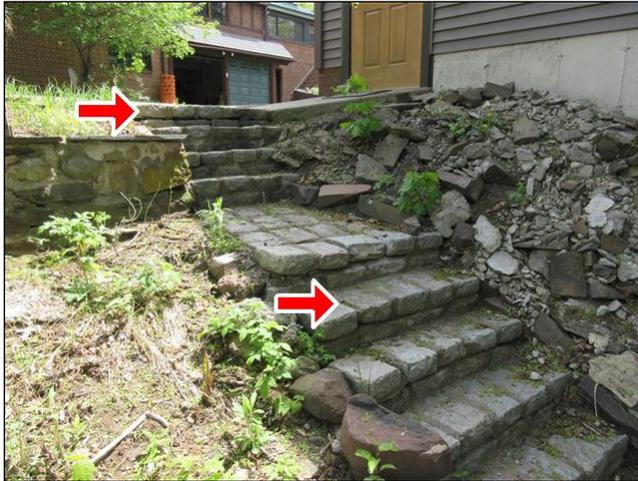
1.11 Item 2(Picture) Rear steps

(2) **Observation:** The stone steps to the right of the detached garage are deteriorating. I noted some loosed stone steps. I did note that there are no railings for the rear steps.

**Recommendation:** Recommend that you have a contractor evaluate the rear steps and make recommendations. Recommend the installation of missing railings.

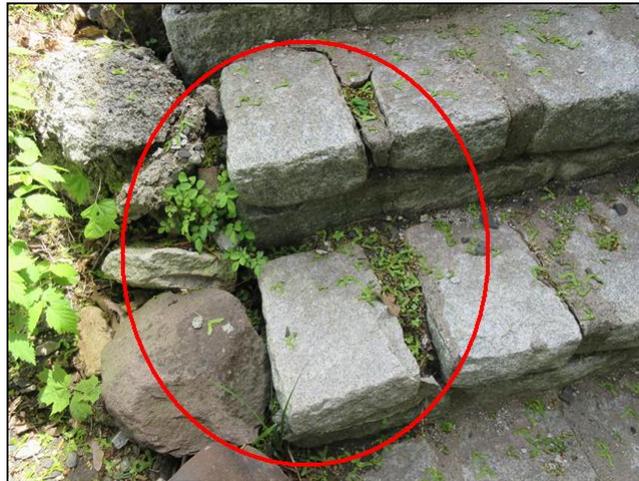
1.11 Item 4(Picture) Loose steps

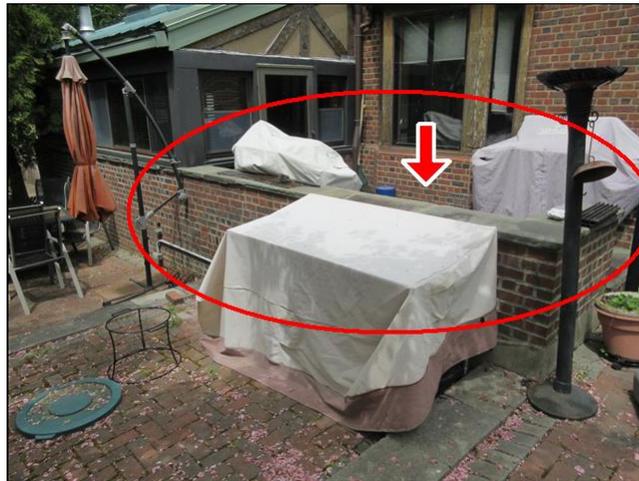
1.12 Item 2(Picture) Patio issues

**Recommendation:** I STRONGLY Recommend having this patio and concrete vault below evaluated by a license contractor and have them make recommendations at that time.

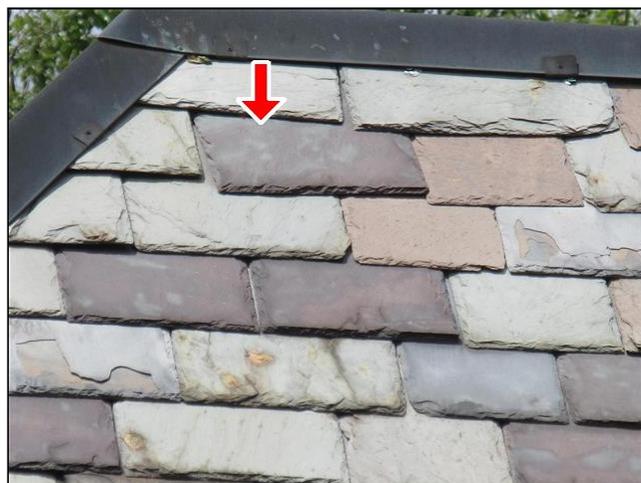
2.0 Item 10(Picture) Detached shingle

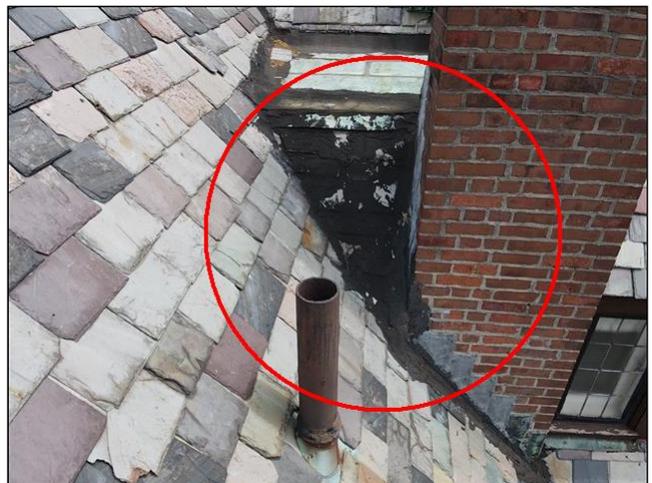
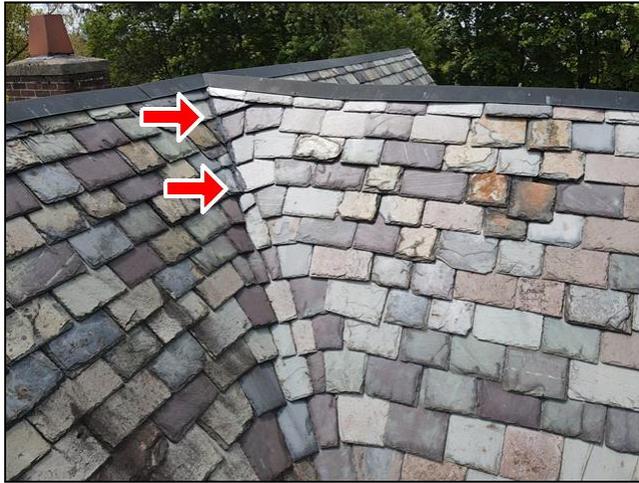
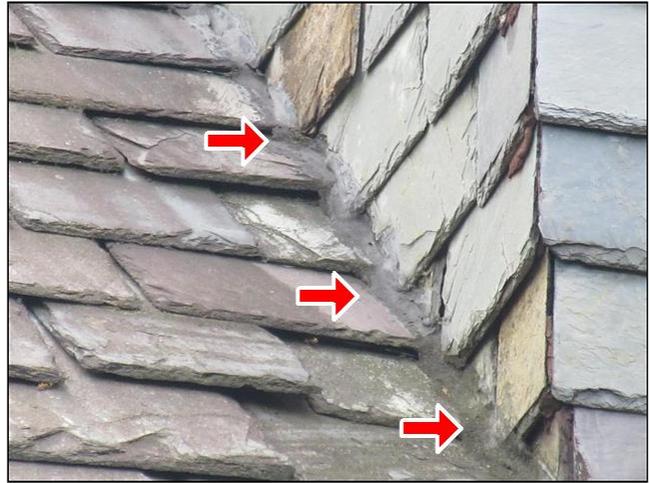
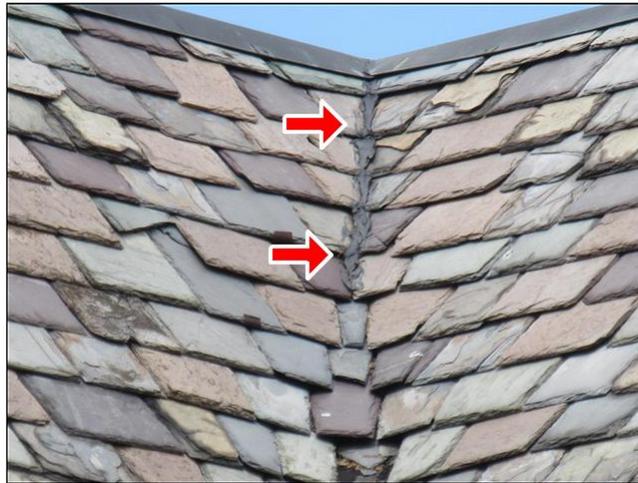
2.0 Item 25(Picture) Tarred valley

2.0 Item 26(Picture) Tarred valley

2.0 Item 27(Picture) Tarred valley

2.0 Item 28(Picture) Tarred valley

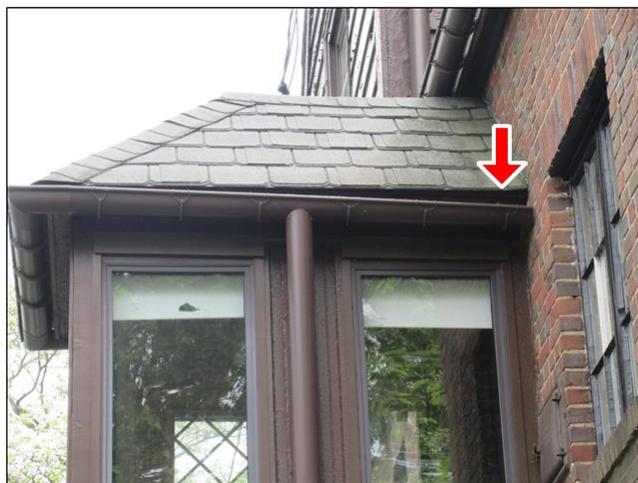
2.3 Item 3(Picture) Gutter not pitched correctly

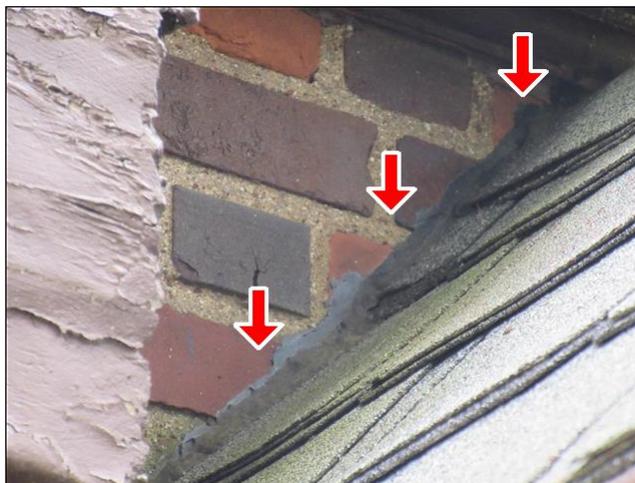
**Observation:** I noted missing step flashing on a section of roofing where it meets the brick siding. Step flashing is required in this area to seal that connection and direct water away from entering the edge.

2.5 Item 1(Picture) Missing step flashing

**Recommendation:** I recommend you have a licensed roofing contractor evaluate this section and make necessary recommendations for repair at that time.

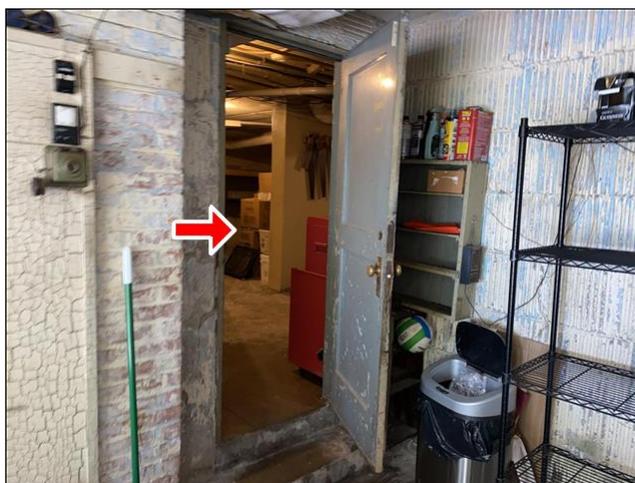
**Observation:** I noted the door from the garage to the living space does not close automatically.

3.5 Item 1(Picture) Garage entry door missing spring hinges

**Recommendation:** Recommend you have a carpenter evaluate this door and make corrections as needed. I would also confirm that the door is fire rated.

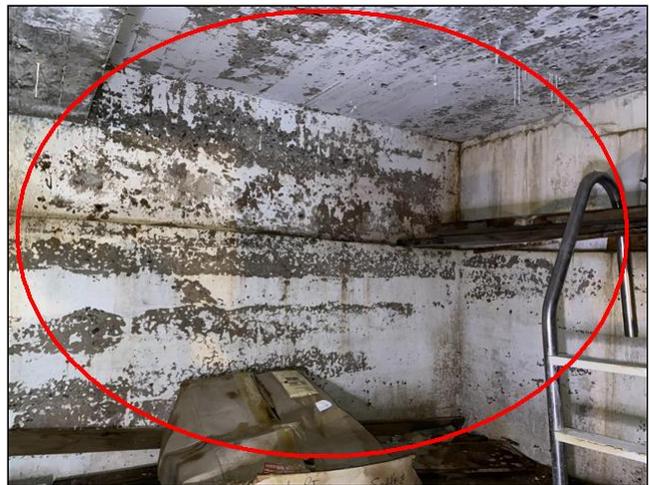
(1) **Observation:** I noted active water intrusion on the basement floor, walls, and ceiling in the pool room under the patio. I also noted prior water intrusion on the basement walls. Excessive moisture was noted in the basement at the time of the inspection.

4.7 Item 2(Picture) Active water intrusion

**Recommendation:** I STORNGLY Recommend you consult with a basement systems company AND licensed contractor concerning these issues.

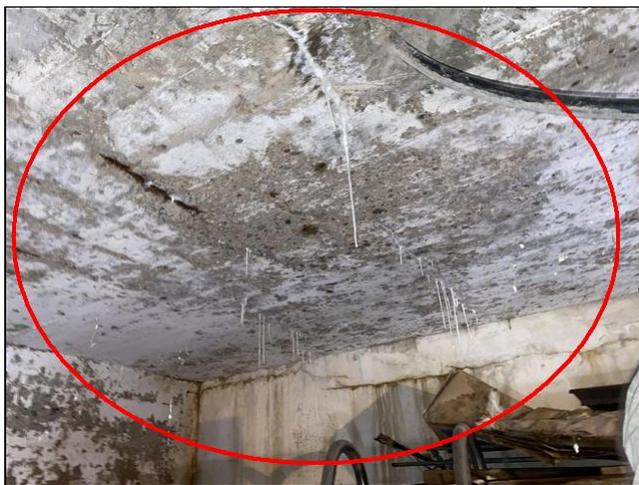
4.7 Item 3(Picture) Active water intrusion

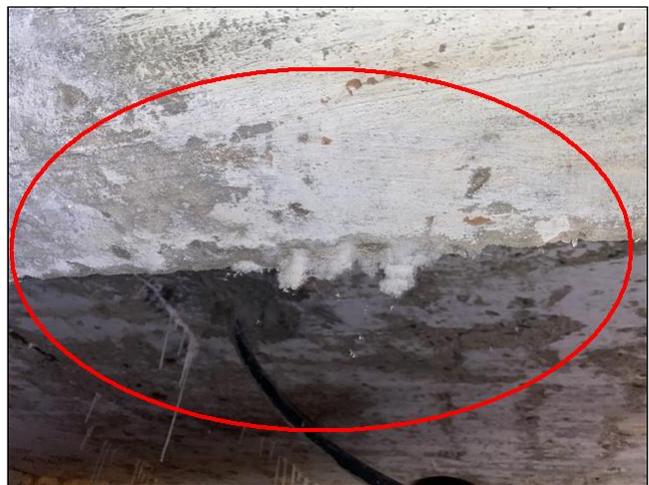
**Observation:** At the time of my inspection, I noted signs of moisture in the basement. The concrete foundation walls have white mineral salt or efflorescence. This usually indicates that there is excessive moisture in the concrete.

4.7 Item 4(Picture) Excessive efflorescence on ceiling

**Recommendation:** Recommend you consult with a basement systems company concerning the areas of moisture noted in the basement.

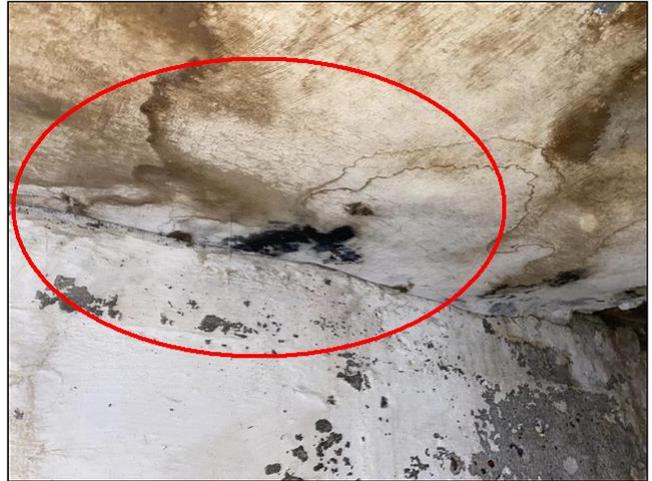
(2) **Observation:** Where visible and accessible, I did note the presence of mold or a mold like substance. The mold like substance appears to be **located on the walls and ceiling in the basement.** This inspection was performed visually, and it was limited to visually accessible areas of the home at the time

4.7 Item 6(Picture) Mold-like substance in basement

**Recommendation:** I do recommend that you have a mold remediation company come in and evaluate this material and at that time make recommendations.

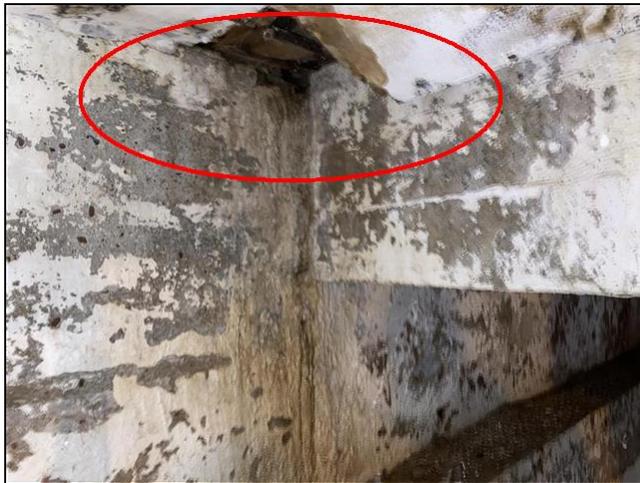
4.7 Item 7(Picture) Mold-like substance in basement

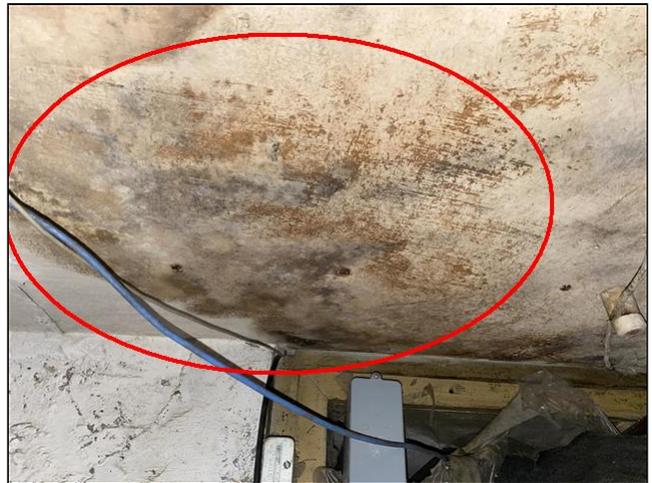
4.7 Item 8(Picture) Mold-like substance in basement

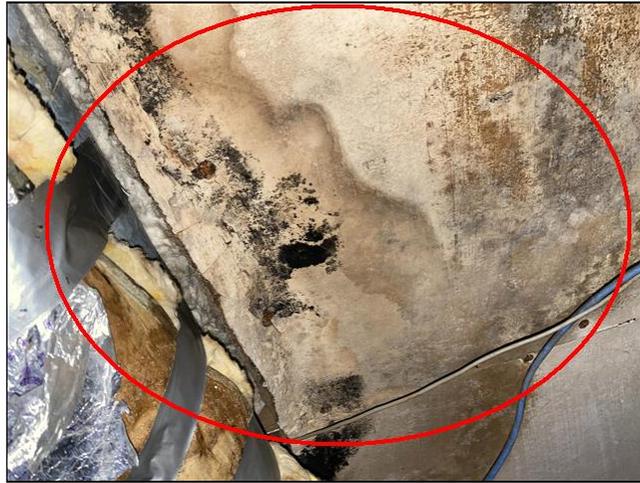
4.7 Item 9(Picture) Mold-like substance in basement

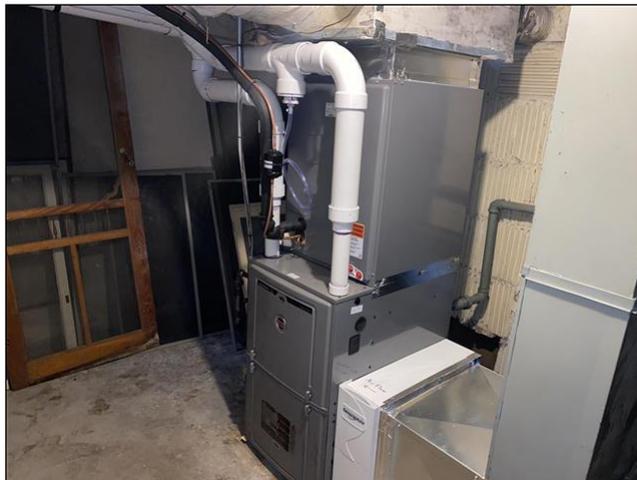
(1) **Observation:** There appears to be a one-zone gas fired furnace in the house. I did fire the unit and it did heat the house accordingly. The unit did not make any unusual noises or fumes and did turn off when the emergency switch on the unit was turned off. The life expectancy of this type of unit is anywhere from 18 - 22 years. The unit functioned normally at the time of the inspection. I did not notice any significant soot or dirt near the air vents throughout the house. According to the manufacture date (if noted), I would place this unit near the start of its life expectancy. Please see styles and materials for the date of manufacture if noted.

5.0 Item 1(Picture) HVAC system

**Recommendation:** I do recommend you have the unit cleaned and serviced if it has not been in the last year.

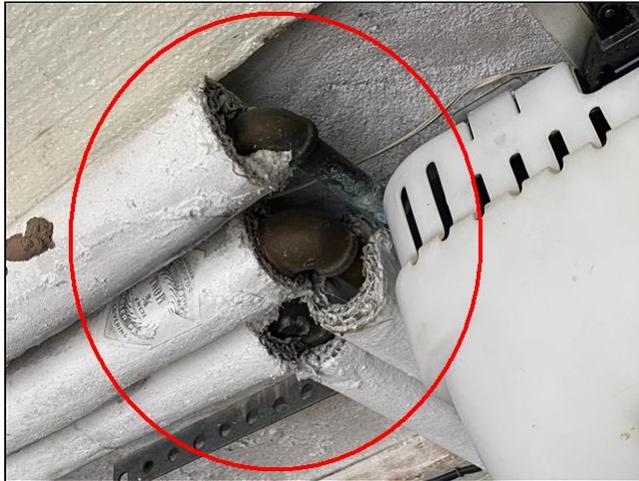
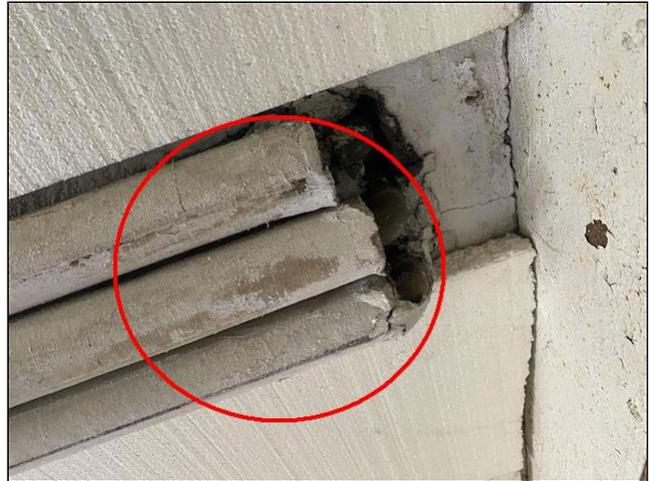
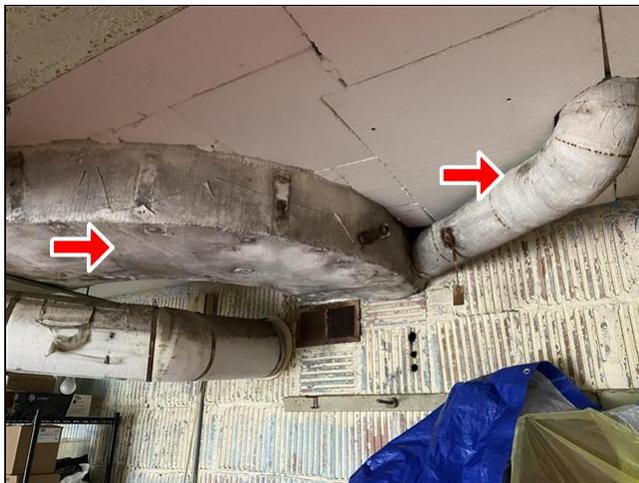
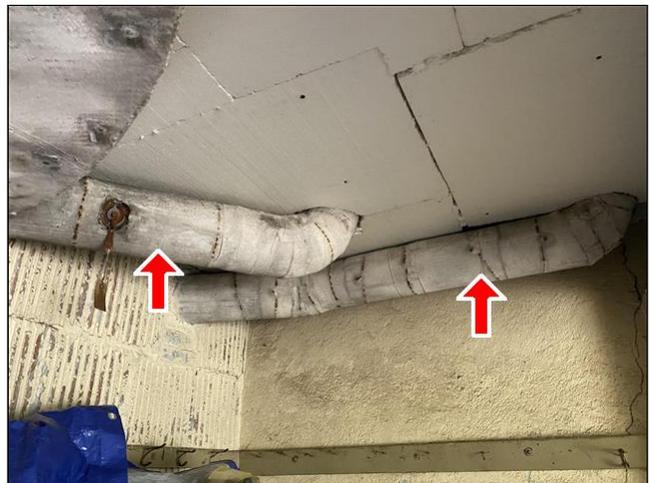
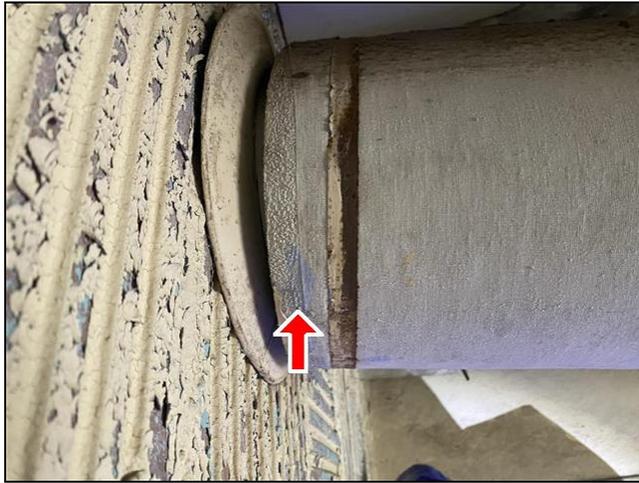
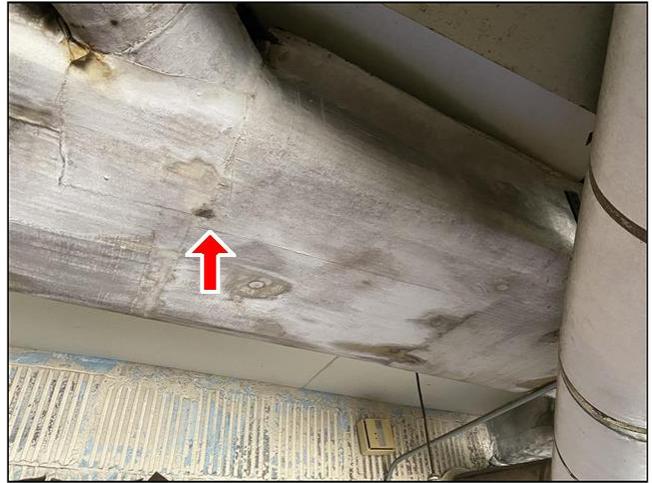
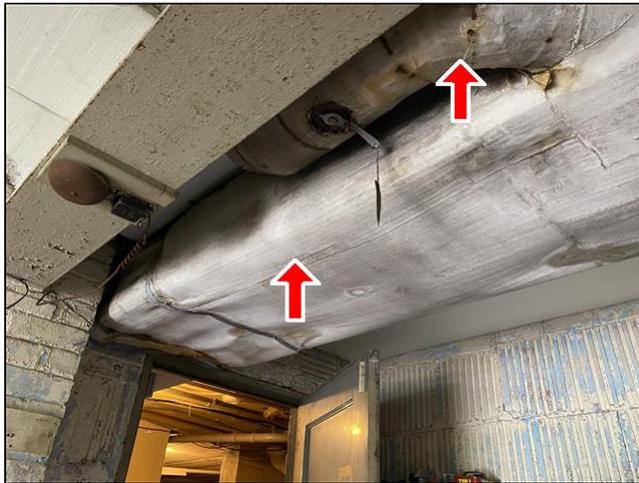
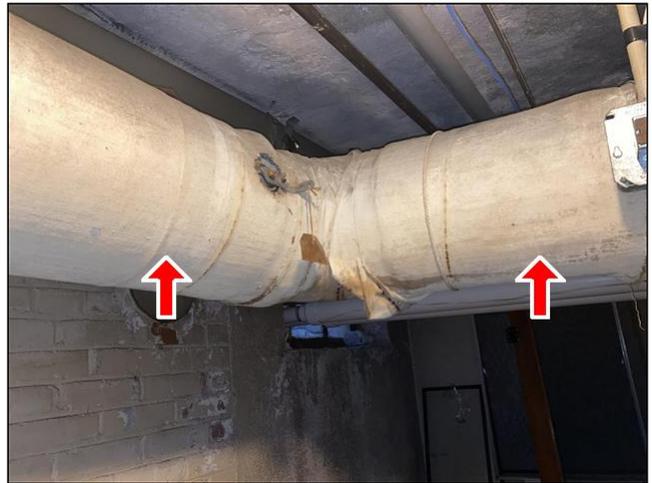
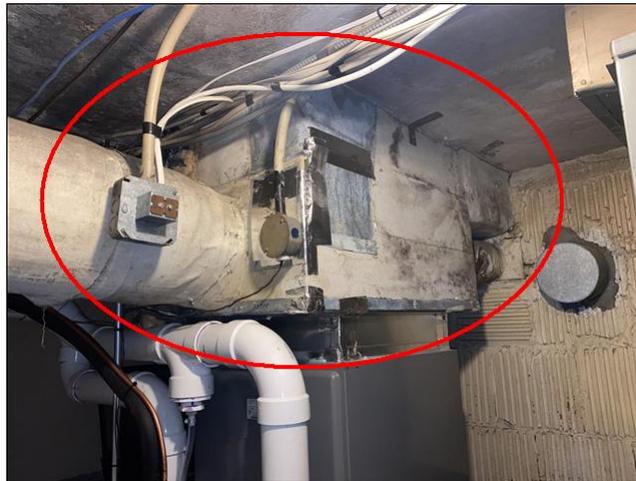
**Observation:** Although excluded from the Connecticut standards of practice, insulation on the boiler and/or distribution piping or ductwork is similar in appearance to materials known to contain asbestos. Although there is a very high probability the material is asbestos, it is simply not possible to visually determine if the material is asbestos with absolute certainty, laboratory analysis is necessary.

5.1 Item 1(Picture) Possible asbestos wrapping

**Recommendation:** Consultation with a licensed asbestos contractor is recommended to determine the proper course of action and to obtain an opinion as to the necessity of air or bulk samples. Due to the age of construction, there may be other materials within the home that contain asbestos but are not identified by this inspection report. Asbestos fibers that get into the air represent a health hazard.

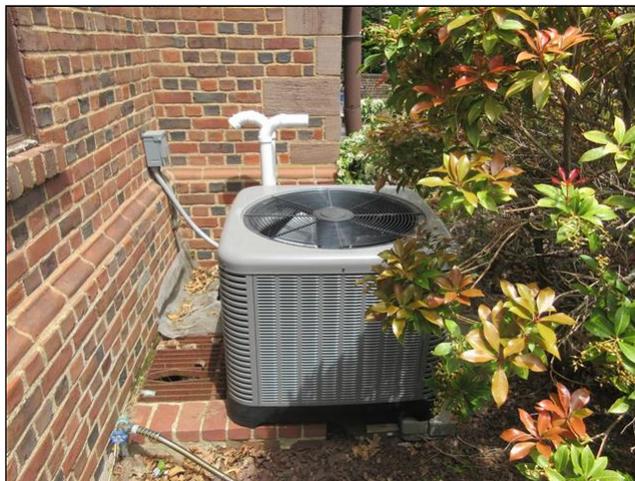
**Observation:** The condenser did show a manufacturing date (*please see styles and material for date of manufacture*). The life expectancy of an AC condenser is approximately 12-15 years. I would place this unit near the start of its expected life cycle. The AC system in the house functioned properly and cool air did come out from all the vents. The service line insulation showed no significant deterioration noted at the time of the inspection.

5.8 Item 1(Picture) AC condenser

**Recommendation:** The AC system should be cleaned and serviced by a licensed heating company if it has not been in the past year.

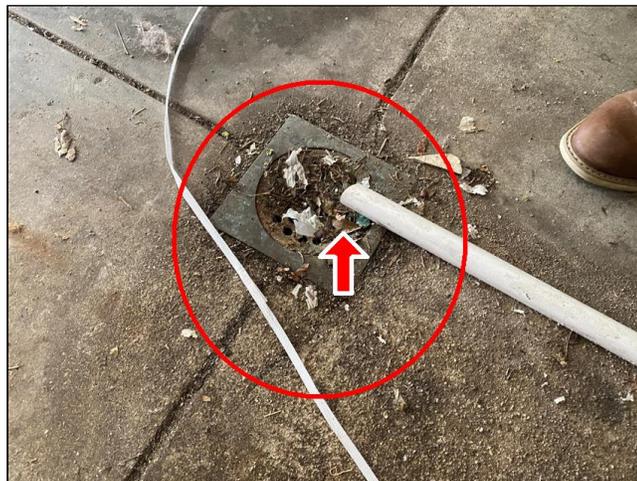
**Observation:** It appears that the condensate line is draining into the floor drain. The present configuration does not appear to be appropriate.

5.10 Item 1(Picture) Condensate line

**Recommendation:** Recommend you have this line evaluated and at that time have the heating contractor make necessary corrections.

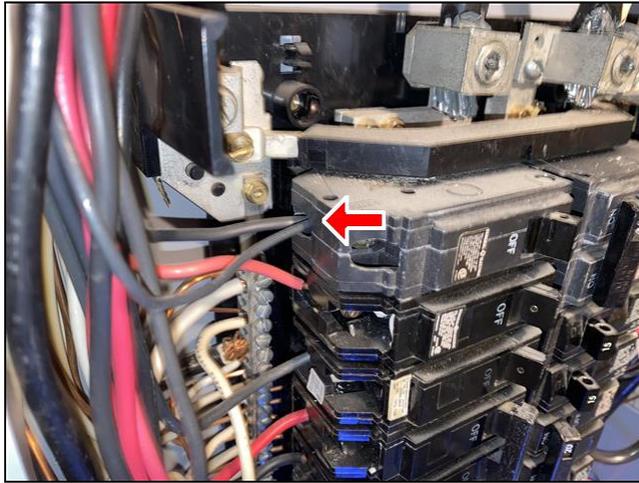
6.0 Item 4(Picture) Double tapped breakers

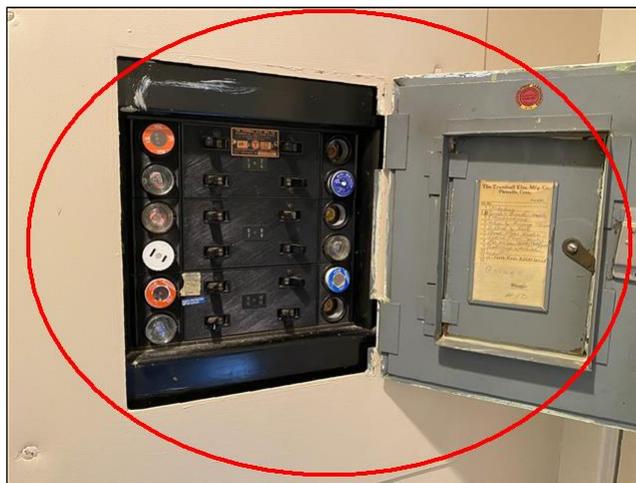
Because of all the problems that can be found with fuse panels, insurance companies may charge a premium for homes with fused services, or they may refuse to insure the home. If you're buying a home with a fused electric service, you would do well to have the service upgraded. The bottom line is that there is nothing inherently wrong with fuses, but most old fuse panels have enough problems to warrant replacement.

6.0 Item 8(Picture) Active fuse box in kitchen

**Recommendation:** I strongly recommend you have the electrical service and the panels as a whole evaluated by a licensed electrician.

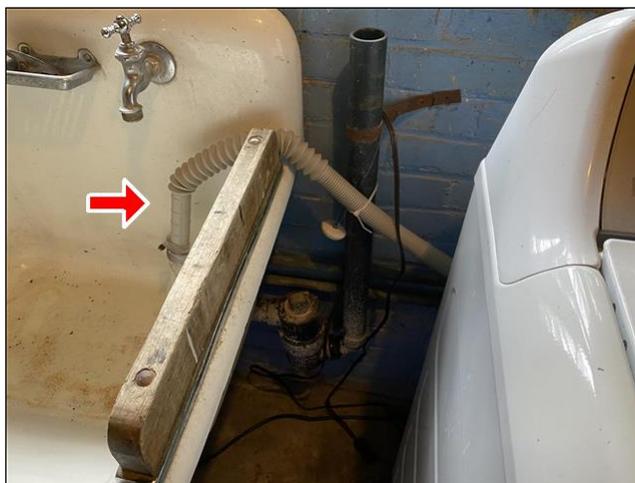
(2) **Observation:** The washing machine was not operated at the time of the inspection. I was unable to locate a washing machine drain. It appears that the washing machine is discharging into the laundry tub.

7.6 Item 3(Picture) Washer draining into laundry tub

**Recommendation:** Recommend you have a plumber install a proper drain.

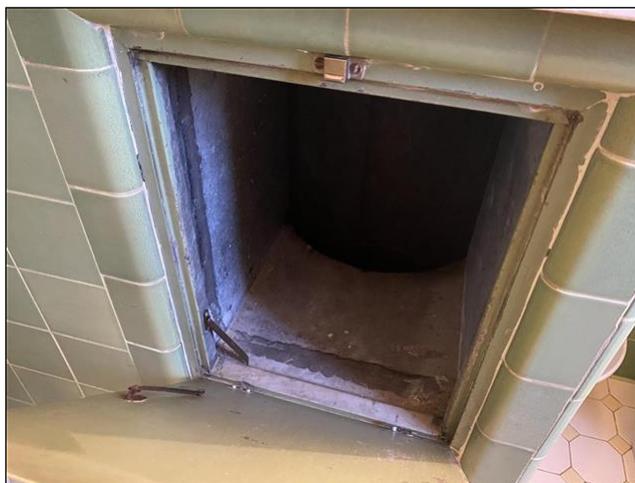
(3) **Observation:** There was a laundry chute noted in the house. Laundry chutes have a number of safety concerns that may warrant discontinued use.

**Note:** *The primary safety concern would be fire spreading easily from one floor to another inside the laundry chute. Laundry chutes should be lined with a non combustibile material; the cover should be self closing, fire rated, and lockable to prevent child access and injury.*

7.6 Item 4(Picture) Laundry chutes

**Recommendation:** You may consider consultation with a licensed contractor for evaluation of the laundry chute, including confirmation that it meets current safety codes.

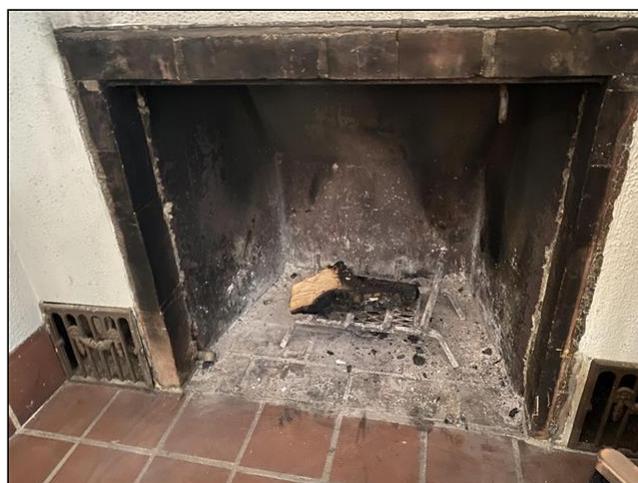
9.1 Item 1(Picture) Fireplace

(1) **Observation:** The liner was mainly visible and appeared in good condition. The damper is present and functional. The firebox appears in good condition. The hearth seems to be in good condition and appears to be the correct dimensions.

**Recommendation:** I recommend a qualified chimney company clean & inspect the chimney for safety if this work has not been done in the past year, and at that time perform a full level 2 inspection of the liner.

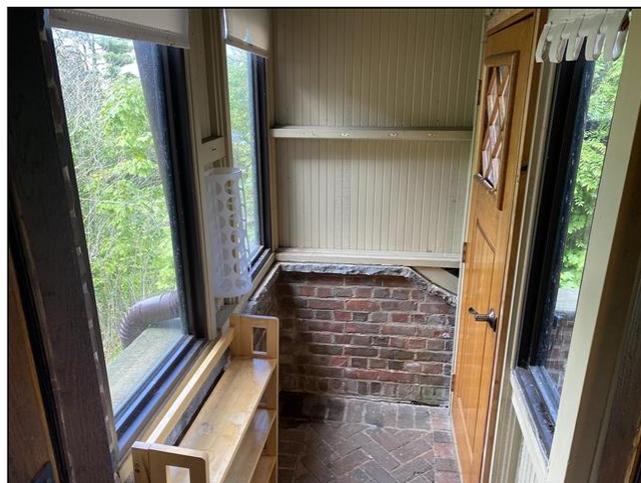
9.2 Item 1(Picture) Front entryway

**Observation:** The entryway in the home appears in good condition. The floor appears solid under foot and level, with no significant issues noted. The walls appear to be in good condition, with no significant issues noted. The ceilings look in good condition with no cracking or staining noted at the time of the inspection.

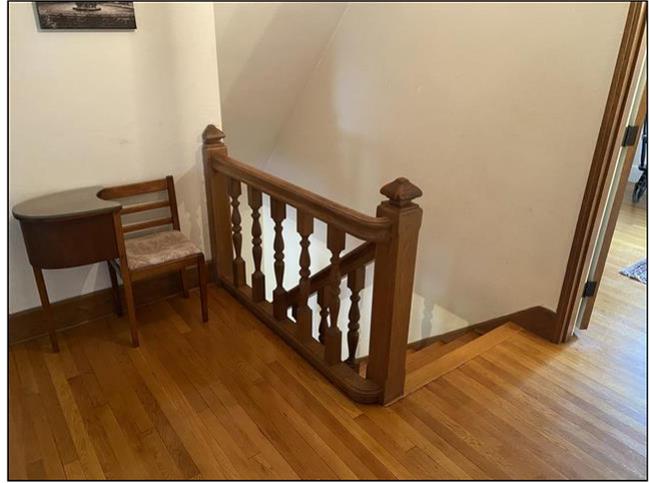
9.3 Item 1(Picture) Stairway

**Observation:** The interior stairs appear to be in good condition. They felt solid under foot and no major deterioration was noted. Handrails appear to be solid to the touch.

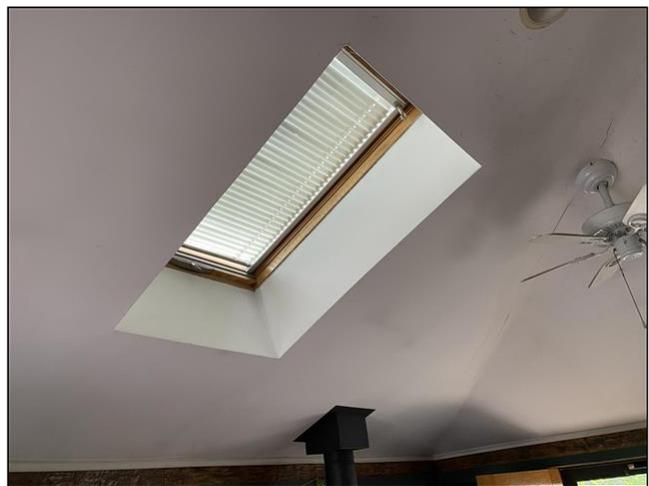
9.5 Item 1(Picture) Skylights

**Observation:** There seem to be several skylights on the roof, from the inside of the house they appeared to be in good condition with no signs of leaking or water staining.

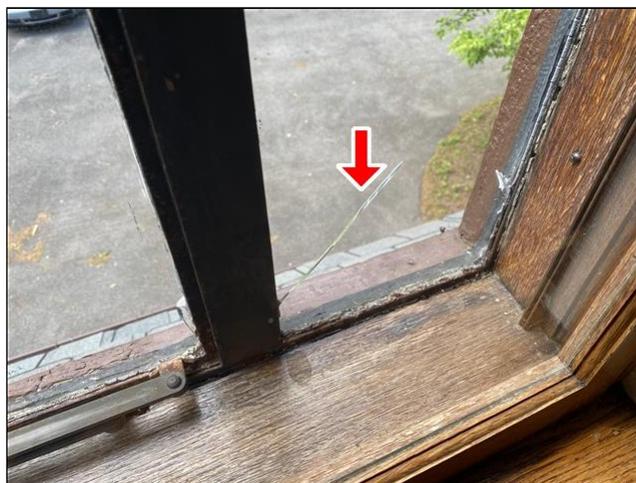
**Observation:** Where visible and accessible the single pane windows appeared, at the time of inspection, to have the following issues: I noted broken glass. There are windows are stuck shut.

9.6 Item 1(Picture) Broken glass

**Recommendations:** Recommend you have a window company come out and evaluate all the windows and make repairs as necessary.

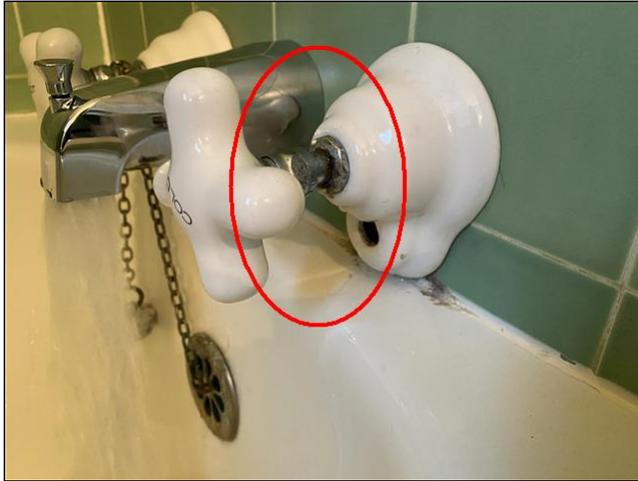
10.0 Item 1(Picture) Leaking tub faucet control

**Recommendation:** Recommend that you have a plumber address the leaking in all bathrooms and make necessary repairs.

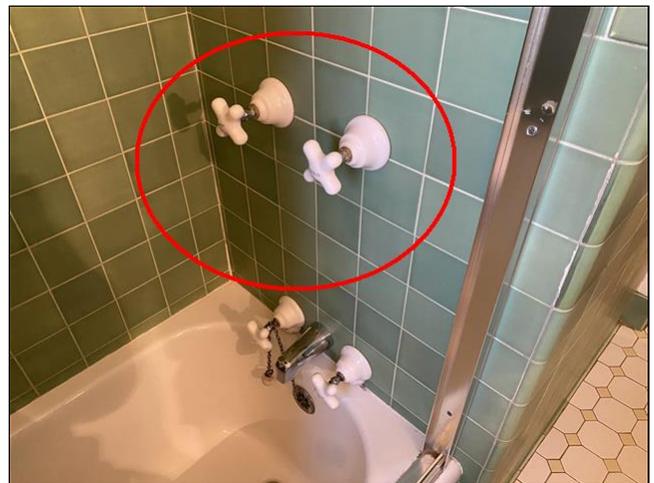
10.1 Item 2(Picture) No anti scald fixtures
